Yellow River		co-0609-002	Severity Score 1																																																																																
<u>Common:</u> 1.3mi SW of Horn Hill <u>Drainage:</u> Blackwater Bay <u>GPS:</u> 31.0578726, -86.5108143 <u>Land owner:</u> LB: Nathaniel Wright, Tr. / RB: USA		<u>County:</u> Covington <u>State:</u> Alabama <u>PLSS:</u> 1N-15E-13 <u>Parcel No.:</u> 2/ 3

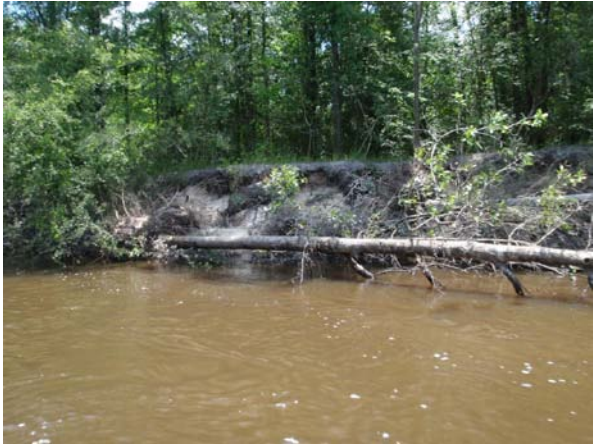
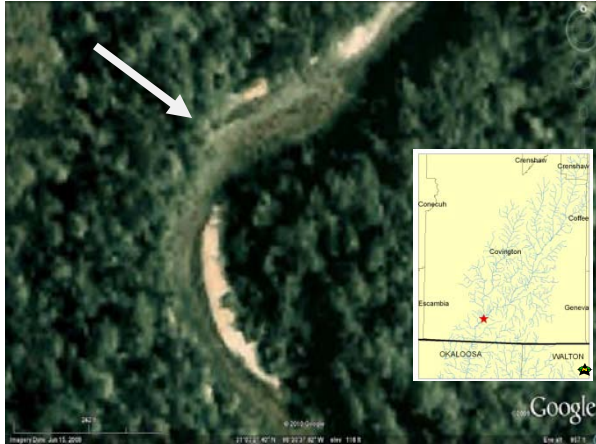
Notes: New growth on bank degradation
