Boggy Creek		co-0810-r-019	Sedimentation Risk Index 34																																																																		
<u>Common:</u> 11.0mi SW of Andalusia <u>Drainage:</u> Hog Foot Creek <u>GPS:</u> 31.154053, -86.538403 <u>Land owner:</u> Judith Anderson		<u>County:</u> Covington <u>State:</u> Alabama <u>PLSS (T-R-S):</u> 2N-15E-10 <u>Parcel No.:</u> 2.01 <u>Road Name:</u> Hog Foot Rd

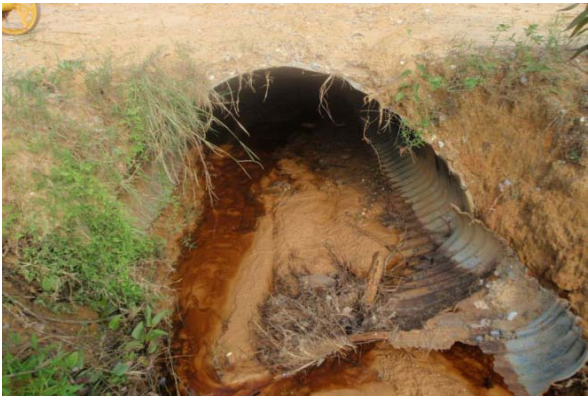
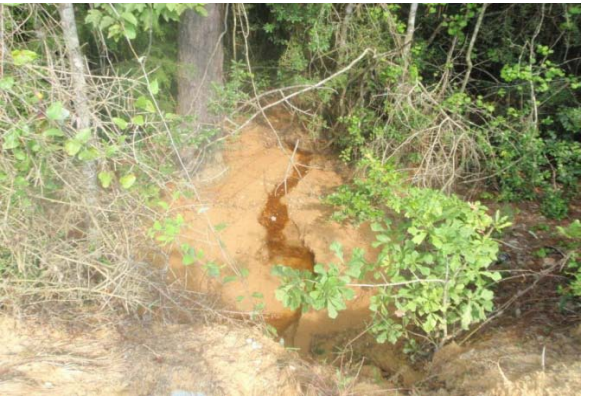
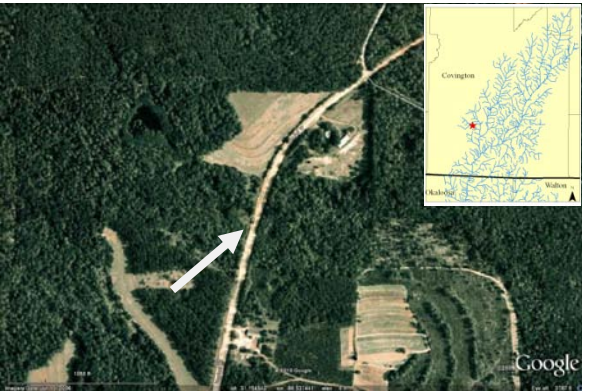
Crossing Structure: DS		DS																																																																			
<table border="1"> <thead> <tr> <th>Risk Factor</th> <th>Ranking</th> <th>Score</th> </tr> </thead> <tbody> <tr><td>US Channel Morph</td><td>PONDED</td><td>1</td></tr> <tr><td>DS Channel Morph</td><td>E</td><td>5</td></tr> <tr><td>DS Bank Alteration</td><td>HIGH</td><td>1</td></tr> <tr><td>Upstream Skew Angle</td><td>5-30°</td><td>3</td></tr> <tr><td>Crossing fill condition</td><td>Poor/Bare soil</td><td>1</td></tr> <tr><td>Inlet/Outlet Condition</td><td>Sed Islands/Scouring</td><td>3</td></tr> <tr><td>Road Approach Material</td><td>All Sand/Clay</td><td>3</td></tr> <tr><td>Potential Eroded Volume Mean</td><td><21 y³</td><td>5</td></tr> <tr><td>Approach Slope Mean</td><td>2.1-4%</td><td>3</td></tr> <tr><td>Soil K Factor</td><td>0.21-0.40</td><td>3</td></tr> <tr><td>Upstream Rt Outlet</td><td>Bare soil</td><td>0</td></tr> <tr><td>Upstream Lt Outlet</td><td>Bare soil</td><td>0</td></tr> <tr><td>Upstream Rt Ditch</td><td>Vegetated</td><td>1</td></tr> <tr><td>Upstream Lt Ditch</td><td>Vegetated</td><td>1</td></tr> <tr><td>Downstream Rt Outlet</td><td>Vegetated</td><td>1</td></tr> <tr><td>Downstream Lt Outlet</td><td>Vegetated</td><td>1</td></tr> <tr><td>Downstream Rt Ditch</td><td>Bare soil</td><td>0</td></tr> <tr><td>Downstream Lt Ditch</td><td>Bare soil</td><td>0</td></tr> <tr><td>Outlet Total</td><td>Partially Improved Outlet System</td><td>3</td></tr> <tr><td>Ditches Total</td><td>Partially Improved Drainage System</td><td>3</td></tr> <tr><td>SRI Total</td><td>High Risk</td><td>34</td></tr> </tbody> </table>		Risk Factor	Ranking	Score	US Channel Morph	PONDED	1	DS Channel Morph	E	5	DS Bank Alteration	HIGH	1	Upstream Skew Angle	5-30°	3	Crossing fill condition	Poor/Bare soil	1	Inlet/Outlet Condition	Sed Islands/Scouring	3	Road Approach Material	All Sand/Clay	3	Potential Eroded Volume Mean	<21 y ³	5	Approach Slope Mean	2.1-4%	3	Soil K Factor	0.21-0.40	3	Upstream Rt Outlet	Bare soil	0	Upstream Lt Outlet	Bare soil	0	Upstream Rt Ditch	Vegetated	1	Upstream Lt Ditch	Vegetated	1	Downstream Rt Outlet	Vegetated	1	Downstream Lt Outlet	Vegetated	1	Downstream Rt Ditch	Bare soil	0	Downstream Lt Ditch	Bare soil	0	Outlet Total	Partially Improved Outlet System	3	Ditches Total	Partially Improved Drainage System	3	SRI Total	High Risk	34

Notes: Receiving large sediment loads from outlets.
