Unnamed tributary		wa-1007-001	Severity Score 12																																																																		
<u>Common:</u> 13.8mi NE of Crestview, .6mi DS from Long Rd <u>Drainage:</u> Long Creek <u>GPS:</u> 30.830327056, -86.35221467 <u>Land owner:</u> Parke Lexington II- Gainsville Ltd		<u>County:</u> Walton <u>State:</u> Florida <u>PLSS(T-R-S):</u> 4N-21W-21 <u>Parcel No.:</u> 1

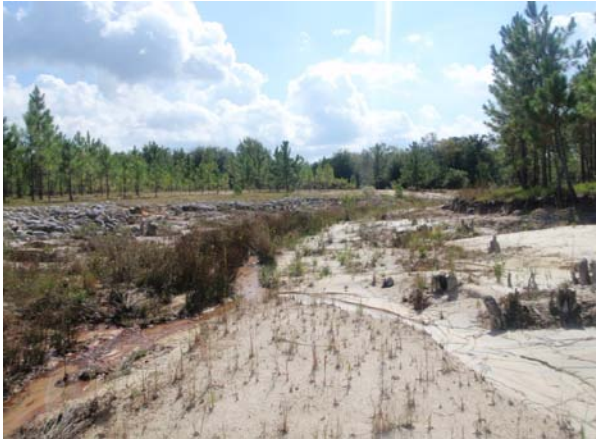
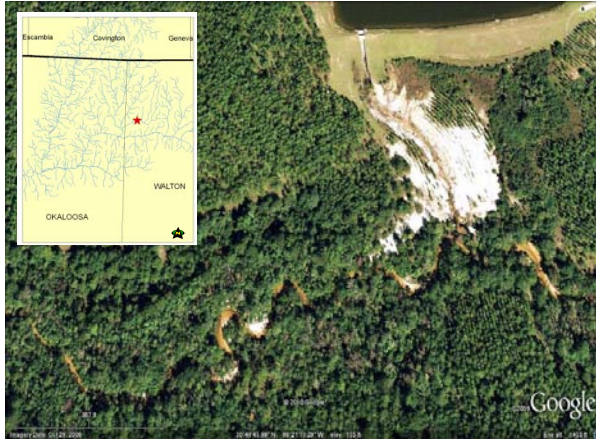
Pond overflow channel going into Long Creek (tree line)- DS																																																																					
<table border="1"> <thead> <tr> <th>Risk Factor</th> <th>Ranking</th> <th>Score</th> </tr> </thead> <tbody> <tr> <td>Channel Stability</td> <td>Fair</td> <td>1</td> </tr> <tr> <td>Channel Alteration</td> <td>In Recovery</td> <td>1.5</td> </tr> <tr> <td>Bank Erosion</td> <td>Active</td> <td>1</td> </tr> <tr> <td>BEHI</td> <td>High</td> <td>1</td> </tr> <tr> <td>Local NPSP</td> <td>Obvious Sources</td> <td>1.5</td> </tr> <tr> <td>Shoring Structures</td> <td>Present</td> <td>1.5</td> </tr> <tr> <td>Pipe Discharge</td> <td>Not Present</td> <td>0</td> </tr> <tr> <td>Water Odors</td> <td>Not Present</td> <td>0</td> </tr> <tr> <td>Fish Passage Barrier</td> <td>Present</td> <td>1.5</td> </tr> <tr> <td>RB: Riparian Buffer</td> <td>0-29 ft</td> <td>0.75</td> </tr> <tr> <td>LB: Riparian Buffer</td> <td>0-29 ft</td> <td>0.75</td> </tr> <tr> <td>RB: Floodplain Access</td> <td>None</td> <td>0.75</td> </tr> <tr> <td>LB: Floodplain Access</td> <td>None</td> <td>0.75</td> </tr> <tr> <td colspan="2">River Threat Index:</td> <td>12</td> </tr> </tbody> </table>		Risk Factor	Ranking	Score	Channel Stability	Fair	1	Channel Alteration	In Recovery	1.5	Bank Erosion	Active	1	BEHI	High	1	Local NPSP	Obvious Sources	1.5	Shoring Structures	Present	1.5	Pipe Discharge	Not Present	0	Water Odors	Not Present	0	Fish Passage Barrier	Present	1.5	RB: Riparian Buffer	0-29 ft	0.75	LB: Riparian Buffer	0-29 ft	0.75	RB: Floodplain Access	None	0.75	LB: Floodplain Access	None	0.75	River Threat Index:		12	<table border="1"> <thead> <tr> <th>Feature</th> <th>Within Range</th> <th>Descriptive Field</th> </tr> </thead> <tbody> <tr> <td>303(d)</td> <td>No</td> <td>N/A</td> </tr> <tr> <td>Wetland Species</td> <td>No</td> <td>N/A</td> </tr> <tr> <td>Rare and Imperiled</td> <td>No</td> <td>N/A</td> </tr> <tr> <td>Land Use/ Cover</td> <td>Yes</td> <td>AGRICULTURAL/ RURAL LAND IN TRANSITION WITHOUT POSITIVE INDICATORS OF INTENDED ACTIVITY</td> </tr> <tr> <td>Candidate Mussels</td> <td>No</td> <td>N/A</td> </tr> <tr> <td>Sturgeon C.H.</td> <td>No</td> <td>N/A</td> </tr> </tbody> </table>		Feature	Within Range	Descriptive Field	303(d)	No	N/A	Wetland Species	No	N/A	Rare and Imperiled	No	N/A	Land Use/ Cover	Yes	AGRICULTURAL/ RURAL LAND IN TRANSITION WITHOUT POSITIVE INDICATORS OF INTENDED ACTIVITY	Candidate Mussels	No	N/A	Sturgeon C.H.	No	N/A

Notes: The overflow channel is lacking a riparian buffer leading to excessive runoff during flood events.
 Some shoring structure has been used, but, ineffectively. Obvious aggradations are found downstream from this site.
