Pond Creek		ok-0710-r-003		Sedimentation Risk Index 44																					
<u>Common:</u>	9.9mi NE of Crestview		<u>County:</u>	Okaloosa																					
<u>Drainage:</u>	Shoal River	<u>GPS:</u> 30.834014, -86.428345	<u>PLSS(T-R-S):</u>	4N-22-22																					
<u>Land owner:</u>	Odessa Jackson		<u>Parcel No.:</u>	1																					
			<u>Road Name:</u>	Lake Ella Rd

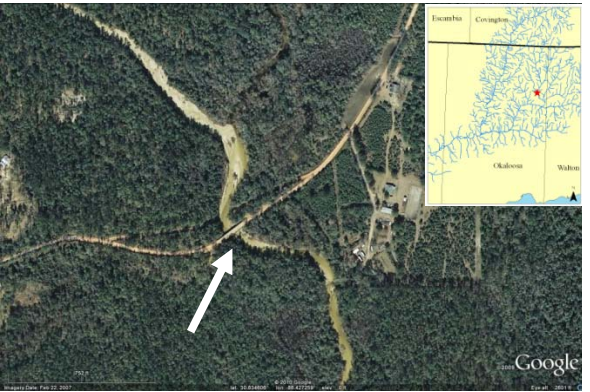
Crossing Structure- Rt Approach		DS																							
Risk Factor	Ranking	Score

Notes: Bridge blew out in March 2009 rainstorm; has not been repaired. 0.1 mi DS from Juniper Creek
