Yellow River		co-0805-002	Severity Score 1.75																																																																																
<u>Common:</u> 10.8mi NW of Florala <u>Drainage:</u> Blackwater Bay <u>GPS:</u> 31.082140978, -86.486431767 <u>Land owner:</u> RB: USA-Conecuh Nat Forest/LB: James & Patricia Battles		<u>County:</u> Covington <u>State:</u> Alabama <u>PLSS:</u> 1N-16E-6 <u>Parcel No.:</u> 2/1

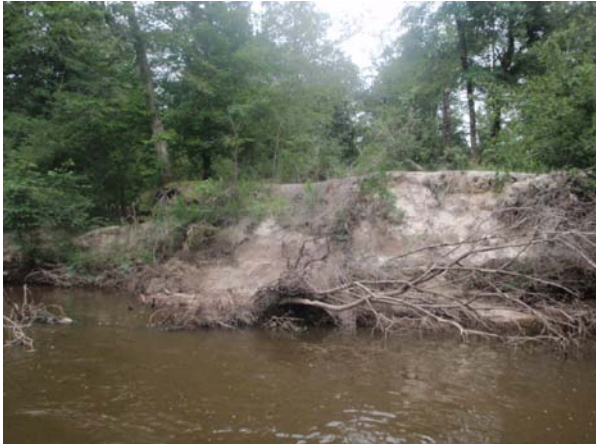
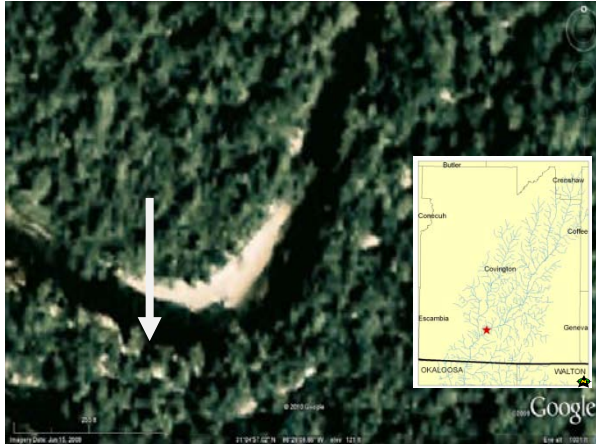
Notes: Some bank erosion apparent, may be natural meander bend incision.
