Unnamed tributary		wa-0706-r-002	Sedimentation Risk Index <b>30</b>																																																																																							
<u>Common:</u> 7.3mi SW of Florala <u>Drainage:</u> Pond Creek <u>GPS:</u> 30.904591, -86.372801 <u>Land owner:</u> William Dixon Jr-US, Michael Lowery-DS		<u>County:</u> Walton <u>State:</u> Florida <u>PLSS(T-R-S):</u> 5N-21-29/30 <u>Parcel No.:</u> 5; 2.001 <u>Road Name:</u> Frost Rd

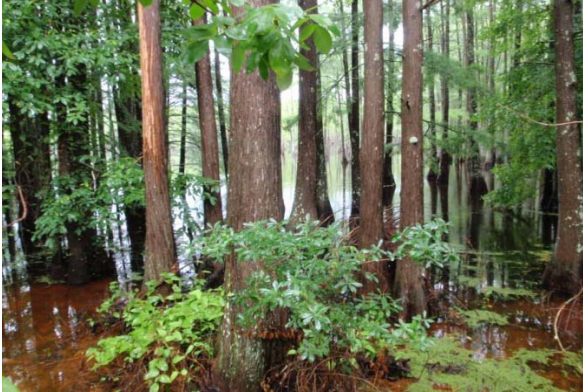
<p>Crossing Structure: DS</p>

Notes: Misplaced culvert.
