Unnamed tributary		co-0904-r-004	Sedimentation Risk Index 34																																																																		
<u>Common:</u> 6.1mi SE of Andalusia <u>Drainage:</u> Five Runs Creek <u>GPS:</u> 31.237184668, -86.420553065 <u>Land owner:</u> Alice Childree -DS, Rayonier Woodlands LLC -US		<u>County:</u> Covington <u>State:</u> Alabama <u>PLSS (T-R-S):</u> 3N-16E-11 <u>Parcel No.:</u> 5; 4 <u>Road Name:</u> Head Farm Rd

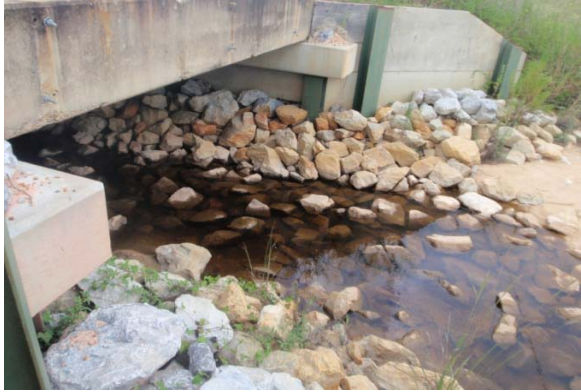
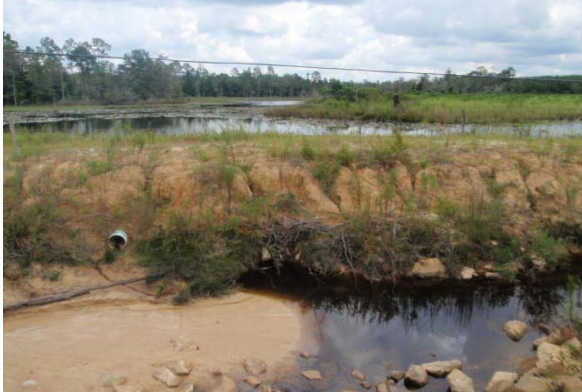
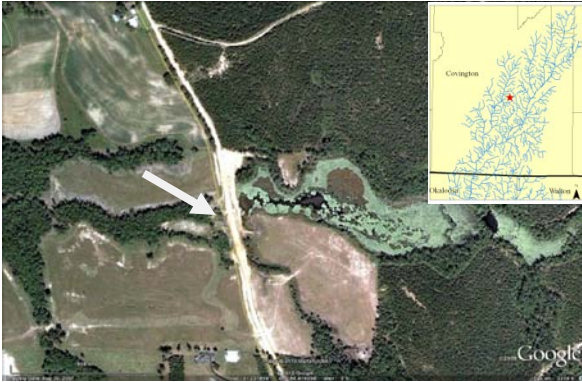
Crossing Structure: DS		US																																																																			
<table border="1"> <thead> <tr> <th>Risk Factor</th> <th>Ranking</th> <th>Score</th> </tr> </thead> <tbody> <tr><td>US Channel Morph</td><td>PONDED</td><td>1</td></tr> <tr><td>DS Channel Morph</td><td>E</td><td>5</td></tr> <tr><td>DS Bank Alteration</td><td>HIGH</td><td>1</td></tr> <tr><td>Upstream Skew Angle</td><td>>30°</td><td>1</td></tr> <tr><td>Crossing fill condition</td><td>Fair/Rip Rap</td><td>3</td></tr> <tr><td>Inlet/Outlet Condition</td><td>Sed Islands/Scouring</td><td>3</td></tr> <tr><td>Road Approach Material</td><td>All Sand/Clay</td><td>3</td></tr> <tr><td>Potential Eroded Volume Mean</td><td><21 y³</td><td>5</td></tr> <tr><td>Approach Slope Mean</td><td>2.1-4%</td><td>3</td></tr> <tr><td>Soil K Factor</td><td><0.20</td><td>5</td></tr> <tr><td>Upstream Rt Outlet</td><td>Rip Rap</td><td>1</td></tr> <tr><td>Upstream Lt Outlet</td><td>Rip Rap</td><td>1</td></tr> <tr><td>Upstream Rt Ditch</td><td>Bare soil</td><td>0</td></tr> <tr><td>Upstream Lt Ditch</td><td>Bare soil</td><td>0</td></tr> <tr><td>Downstream Rt Outlet</td><td>Bare soil</td><td>0</td></tr> <tr><td>Downstream Lt Outlet</td><td>Bare soil</td><td>0</td></tr> <tr><td>Downstream Rt Ditch</td><td>Bare soil</td><td>0</td></tr> <tr><td>Downstream Lt Ditch</td><td>Bare soil</td><td>0</td></tr> <tr><td>Outlet Total</td><td>Partially Improved Outlet System</td><td>3</td></tr> <tr><td>Ditches Total</td><td>Unimproved Drainage System</td><td>1</td></tr> <tr><td>SRI Total</td><td>High Risk</td><td>34</td></tr> </tbody> </table>		Risk Factor	Ranking	Score	US Channel Morph	PONDED	1	DS Channel Morph	E	5	DS Bank Alteration	HIGH	1	Upstream Skew Angle	>30°	1	Crossing fill condition	Fair/Rip Rap	3	Inlet/Outlet Condition	Sed Islands/Scouring	3	Road Approach Material	All Sand/Clay	3	Potential Eroded Volume Mean	<21 y ³	5	Approach Slope Mean	2.1-4%	3	Soil K Factor	<0.20	5	Upstream Rt Outlet	Rip Rap	1	Upstream Lt Outlet	Rip Rap	1	Upstream Rt Ditch	Bare soil	0	Upstream Lt Ditch	Bare soil	0	Downstream Rt Outlet	Bare soil	0	Downstream Lt Outlet	Bare soil	0	Downstream Rt Ditch	Bare soil	0	Downstream Lt Ditch	Bare soil	0	Outlet Total	Partially Improved Outlet System	3	Ditches Total	Unimproved Drainage System	1	SRI Total	High Risk	34

Notes: 2 culverts draining the pond to the bridge crossing.
