Unnamed tributary		co-0901-r-010	Sedimentation Risk Index <b>42</b>																																																																		
<u>Common:</u> 12.6mi NW of Florala <u>Drainage:</u> Poplar Creek <u>GPS:</u> 31.172833812, -86.412936652 <u>Land owner:</u> B.E. & Pearl Creel -DS, T.Ivey Powell & Sons Inc-US		<u>County:</u> Covington <u>State:</u> Alabama <u>PLSS (T-R-S):</u> 2N-16E-2/1 <u>Parcel No.:</u> 1;3 <u>Road Name:</u> Tim Powell Rd

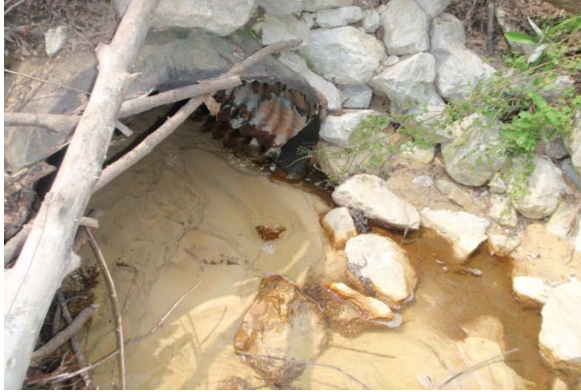
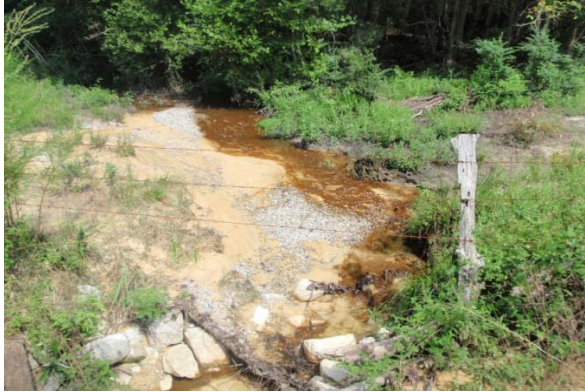
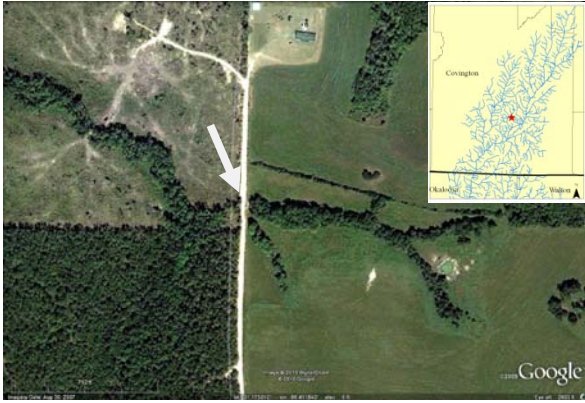
Crossing Structure: US		US																																																																			
<table border="1"> <thead> <tr> <th>Risk Factor</th> <th>Ranking</th> <th>Score</th> </tr> </thead> <tbody> <tr><td>US Channel Morph</td><td>E</td><td>5</td></tr> <tr><td>DS Channel Morph</td><td>DA</td><td>3</td></tr> <tr><td>DS Bank Alteration</td><td>MINOR/PARTIAL</td><td>3</td></tr> <tr><td>Upstream Skew Angle</td><td>5-30°</td><td>3</td></tr> <tr><td>Crossing fill condition</td><td>Fair/Rip Rap</td><td>3</td></tr> <tr><td>Inlet/Outlet Condition</td><td>Sed Islands/Scouring</td><td>3</td></tr> <tr><td>Road Approach Material</td><td>All Aggregate</td><td>5</td></tr> <tr><td>Potential Eroded Volume Mean</td><td>&lt;21 y<sup>3</sup></td><td>5</td></tr> <tr><td>Approach Slope Mean</td><td>&gt;4%</td><td>1</td></tr> <tr><td>Soil K Factor</td><td>&lt;0.20</td><td>5</td></tr> <tr><td>Upstream Rt Outlet</td><td>Vegetated</td><td>1</td></tr> <tr><td>Upstream Lt Outlet</td><td>Vegetated</td><td>1</td></tr> <tr><td>Upstream Rt Ditch</td><td>Bare soil</td><td>0</td></tr> <tr><td>Upstream Lt Ditch</td><td>Bare soil</td><td>0</td></tr> <tr><td>Downstream Rt Outlet</td><td>Vegetated</td><td>1</td></tr> <tr><td>Downstream Lt Outlet</td><td>Vegetated</td><td>1</td></tr> <tr><td>Downstream Rt Ditch</td><td>Bare soil</td><td>0</td></tr> <tr><td>Downstream Lt Ditch</td><td>Bare soil</td><td>0</td></tr> <tr><td>Outlet Total</td><td>Improved Outlet System</td><td>5</td></tr> <tr><td>Ditches Total</td><td>Unimproved Drainage System</td><td>1</td></tr> <tr><td><b>SRI Total</b></td><td><b>Medium Risk</b></td><td><b>42</b></td></tr> </tbody> </table>		Risk Factor	Ranking	Score	US Channel Morph	E	5	DS Channel Morph	DA	3	DS Bank Alteration	MINOR/PARTIAL	3	Upstream Skew Angle	5-30°	3	Crossing fill condition	Fair/Rip Rap	3	Inlet/Outlet Condition	Sed Islands/Scouring	3	Road Approach Material	All Aggregate	5	Potential Eroded Volume Mean	<21 y <sup>3</sup>	5	Approach Slope Mean	>4%	1	Soil K Factor	<0.20	5	Upstream Rt Outlet	Vegetated	1	Upstream Lt Outlet	Vegetated	1	Upstream Rt Ditch	Bare soil	0	Upstream Lt Ditch	Bare soil	0	Downstream Rt Outlet	Vegetated	1	Downstream Lt Outlet	Vegetated	1	Downstream Rt Ditch	Bare soil	0	Downstream Lt Ditch	Bare soil	0	Outlet Total	Improved Outlet System	5	Ditches Total	Unimproved Drainage System	1	<b>SRI Total</b>	<b>Medium Risk</b>	<b>42</b>

Notes: Fencing across US. Washed in aggregate.
