Blaze Branch		cr-1103-r-005	Sedimentation Risk Index 36																																																																		
<u>Common:</u> 1.2mi SW of Pine Level <u>Drainage:</u> Lightwood Knot <u>GPS:</u> 31.469551544, -86.205979180 <u>Land owner:</u> Robert Beach -US, G.A. Lindsey -DS		<u>County:</u> Crenshaw <u>State:</u> Alabama <u>PLSS (T-R-S):</u> 6N-18E-25 <u>Parcel No.:</u> 2.001,3 <u>Road Name:</u> Kilcrease Rd

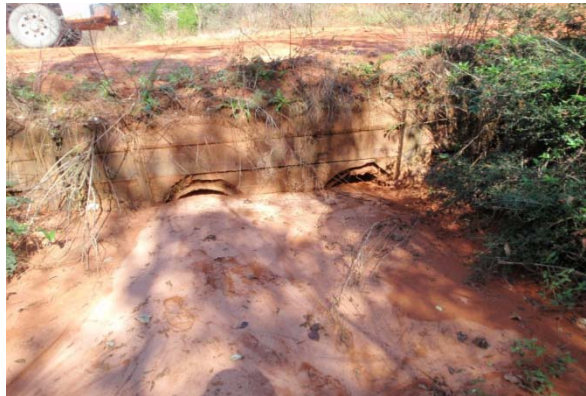
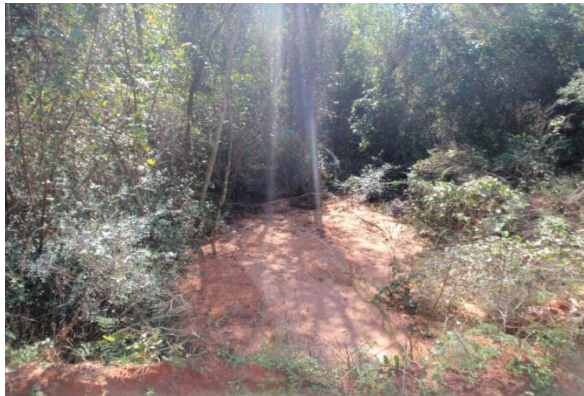
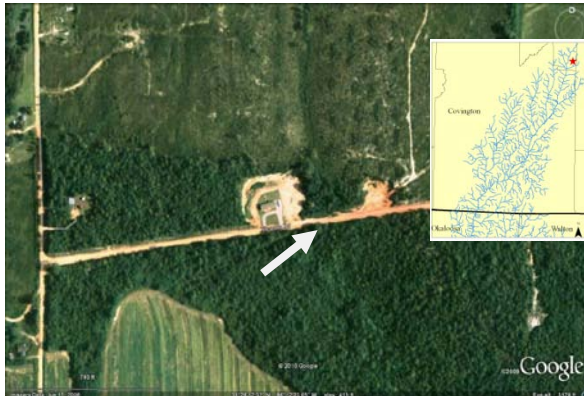
Notes: Eroding slope Lt approach. Blocked culverts from bare soil and ditches influencing score.
