Yellow River		co-0824-004	Severity Score 2.5																																																																																
<u>Common:</u> 2.8mi SW of Horn Hill <u>Drainage:</u> Blackwater Bay <u>GPS:</u> 31.219101448, -86.352660805 <u>Land owner:</u> LB: Dixon Family LE/ RB: William Hurbert Henderson Jr.		<u>County:</u> Covington <u>State:</u> Alabama <u>PLSS:</u> 3N-17E-21 <u>Parcel No.:</u> 1/2

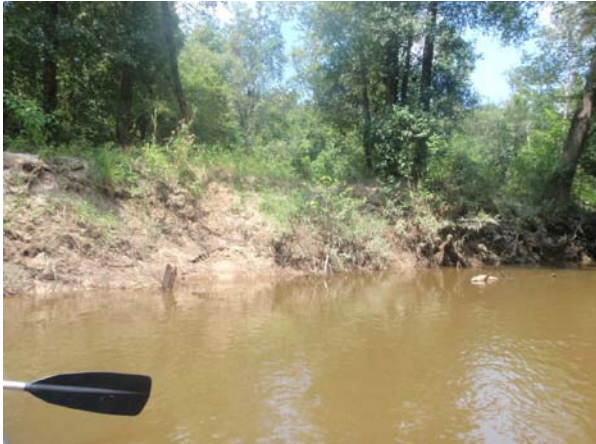
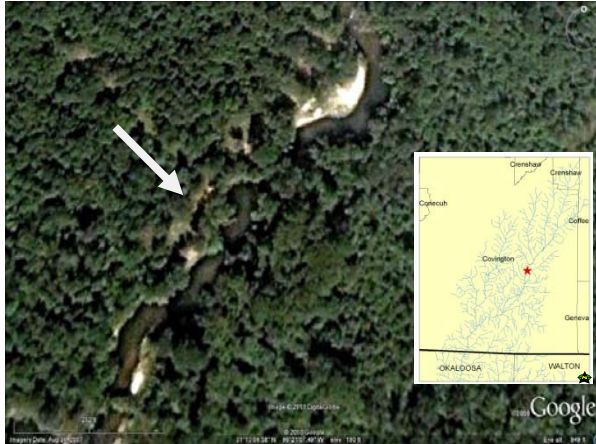
RB																																																																																			
<table border="1"> <thead> <tr> <th>Risk Factor</th> <th>Ranking</th> <th>Score</th> </tr> </thead> <tbody> <tr><td>Channel Stability</td><td>Good</td><td>0.5</td></tr> <tr><td>Channel Alteration</td><td>None</td><td>0</td></tr> <tr><td>Bank Erosion</td><td>Active</td><td>1</td></tr> <tr><td>BEHI</td><td>Moderate</td><td>0.5</td></tr> <tr><td>Local NPSP</td><td>No Evidence</td><td>0</td></tr> <tr><td>Shoring Structures</td><td>Not Present</td><td>0</td></tr> <tr><td>Pipe Discharge</td><td>Not Present</td><td>0</td></tr> <tr><td>Water Odors</td><td>Not Present</td><td>0</td></tr> <tr><td>Fish Passage Barrier</td><td>Not Present</td><td>0</td></tr> <tr><td>RB: Riparian Buffer</td><td>30-49 ft</td><td>0.5</td></tr> <tr><td>LB: Riparian Buffer</td><td>100+ ft</td><td>0</td></tr> <tr><td>RB: Floodplain Access</td><td>Full</td><td>0</td></tr> <tr><td>LB: Floodplain Access</td><td>Full</td><td>0</td></tr> <tr><td><b>River Threat Index:</b></td><td></td><td><b>2.5</b></td></tr> </tbody> </table>	Risk Factor	Ranking	Score	Channel Stability	Good	0.5	Channel Alteration	None	0	Bank Erosion	Active	1	BEHI	Moderate	0.5	Local NPSP	No Evidence	0	Shoring Structures	Not Present	0	Pipe Discharge	Not Present	0	Water Odors	Not Present	0	Fish Passage Barrier	Not Present	0	RB: Riparian Buffer	30-49 ft	0.5	LB: Riparian Buffer	100+ ft	0	RB: Floodplain Access	Full	0	LB: Floodplain Access	Full	0	<b>River Threat Index:</b>		<b>2.5</b>	<table border="1"> <thead> <tr> <th>Feature</th> <th>Within Range</th> <th>Descriptive Field</th> </tr> </thead> <tbody> <tr><td>303(d)</td><td>No</td><td>N/A</td></tr> <tr><td>Wetland Species</td><td>No</td><td>N/A</td></tr> <tr><td>Rare and Imperiled</td><td>No</td><td>N/A</td></tr> <tr><td>Land Use/Cover</td><td>Yes</td><td>N/A / EAST GULF COASTAL PLAIN SMALL STREAM AND RIVER FLOODPLAIN FOREST</td></tr> <tr><td>Candidate Mussels</td><td>Yes</td><td>SOUTHERN SANDSHELL</td></tr> <tr><td>Sturgeon C.H.</td><td>No</td><td>N/A</td></tr> <tr> <td colspan="3"><b>Additional Site Features</b></td></tr> <tr> <td><u>Stream Channel Woody Material:</u></td><td></td><td>Moderate</td></tr> <tr> <td><u>Impoundments:</u></td><td></td><td>None</td></tr> <tr> <td><u>Substrate Composition:</u></td><td></td><td>Medium Sand</td></tr> <tr> <td><u>Bank Material:</u></td><td></td><td>Sand</td></tr> </tbody> </table>		Feature	Within Range	Descriptive Field	303(d)	No	N/A	Wetland Species	No	N/A	Rare and Imperiled	No	N/A	Land Use/Cover	Yes	N/A / EAST GULF COASTAL PLAIN SMALL STREAM AND RIVER FLOODPLAIN FOREST	Candidate Mussels	Yes	SOUTHERN SANDSHELL	Sturgeon C.H.	No	N/A	<b>Additional Site Features</b>			<u>Stream Channel Woody Material:</u>		Moderate	<u>Impoundments:</u>		None	<u>Substrate Composition:</u>		Medium Sand	<u>Bank Material:</u>		Sand

Notes: New growth on eroded site
