Unnamed tributary		ok-0528-r-003	Sedimentation Risk Index 48																																																																		
<u>Common:</u> 3.4mi NE of Laurel Hill <u>Drainage:</u> Horsehead Creek <i>GPS:</i> 30.982058, -86.405300 <u>Land owner:</u> Helen & Robert Pagnini- US, Catherine & Cory Harned- US		<u>County:</u> Okaloosa <i>State:</i> Florida <u>PLSS(T-R-S):</u> 6N-22-25 <u>Parcel No.:</u> 1.002, 5 <u>Road Name:</u> Robinson Rd

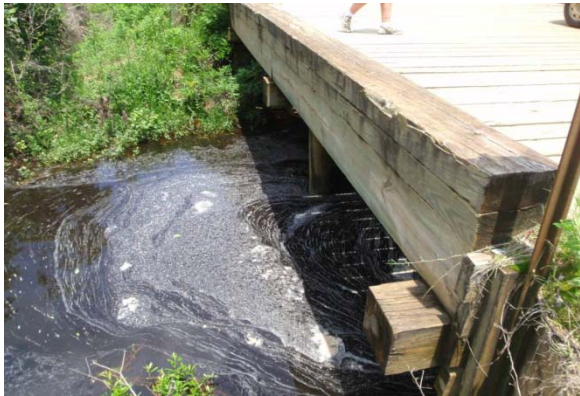
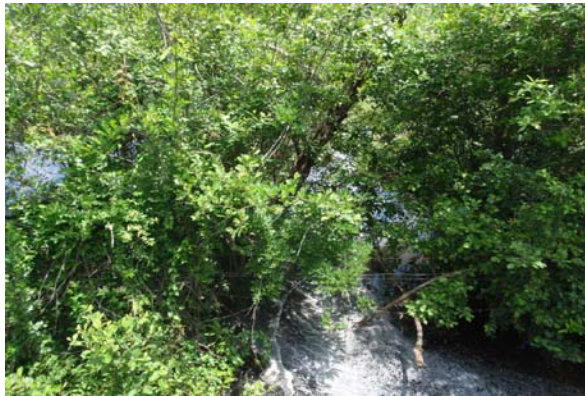
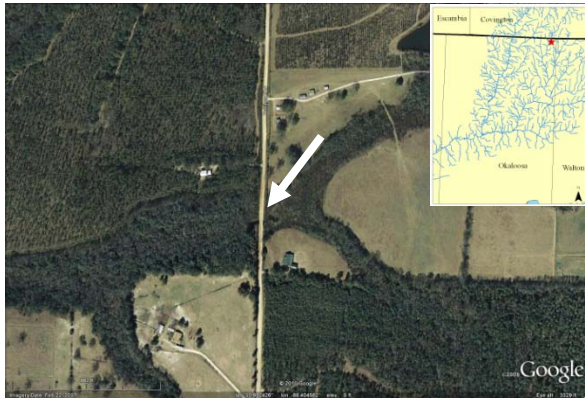
Notes: Outfall drop over beaver dam.
