Unnamed tributary		co-0731-r-005		Sedimentation Risk Index 42																																																																			
<u>Common:</u> 4.1mi NW of Florala <u>Drainage:</u> Horsehead Creek <i>GPS:</i> 31.031038, -86.391598 <u>Land owner:</u> Carol Coon -US, Rayonier Forest Resources LP-DS		<u>County:</u> Covington <u>PLSS (T-R-S):</u> 1N-17E-19/30 <u>Parcel No.:</u> 5.02; 1 <u>Road Name:</u> Union Church Rd		<u>State:</u> Alabama

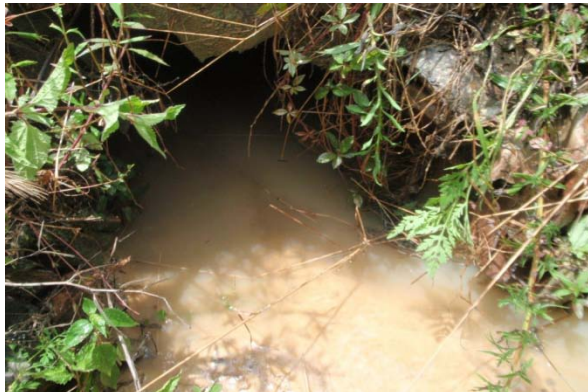
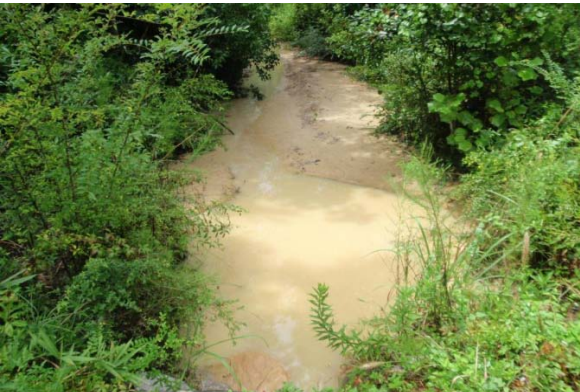
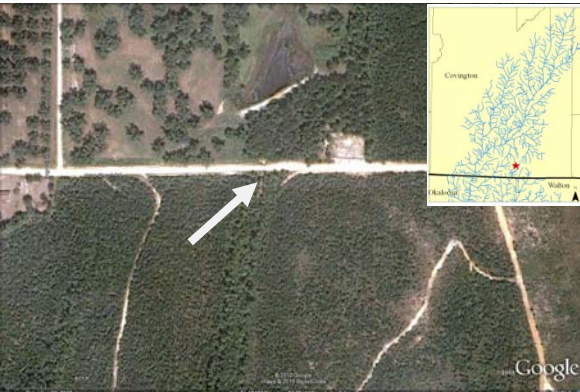
Risk Factor	Ranking	Score																																																																					
US Channel Morph	E	5																																																																					
DS Channel Morph	E	5																																																																					
DS Bank Alteration	HIGH	1																																																																					
Upstream Skew Angle	<5°	5																																																																					
Crossing fill condition	Good/Vegetated	5																																																																					
Inlet/Outlet Condition	Sed Islands/Scouring	3																																																																					
Road Approach Material	All Sand/Clay	3																																																																					
Potential Eroded Volume Mean	>40 y ³	1																																																																					
Approach Slope Mean	2.1-4%	3

Soil K Factor	<0.20	5																																																																					
Upstream Rt Outlet	Vegetated	1																																																																					
Upstream Lt Outlet	Vegetated	1																																																																					
Upstream Rt Ditch	Bare soil	0																																																																					
Upstream Lt Ditch	Bare soil	0																																																																					
Downstream Rt Outlet	Vegetated	1																																																																					
Downstream Lt Outlet	Vegetated	1																																																																					
Downstream Rt Ditch	Bare soil	0																																																																					
Downstream Lt Ditch	Bare soil	0																																																																					
Outlet Total	Improved Outlet System	5

Ditches Total	Unimproved Drainage System	1																																																																					
SRI Total	Medium Risk	42																																																																					
Additional Site Features <u>Crossing Type and Quantity:</u> Culvert, 1 <u>Crossing Materials:</u> Metal <u>Soil Types:</u> BoC,CdB,CdC,DmB,FuB,MBA <u>Rt Approach Prism Fill:</u> 2.0in <u>Lt Approach Prism Fill:</u> 2.5in		<table border="1"> <thead> <tr> <th>Feature</th> <th>Within Range</th> <th>Descriptive Field</th> </tr> </thead> <tbody> <tr><td>303(d)</td><td>No</td><td>N/A</td></tr> <tr><td>Wetland Species</td><td>No</td><td>N/A</td></tr> <tr><td>Rare and Imperiled</td><td>No</td><td>N/A</td></tr> <tr><td>Land Use/Cover</td><td>No</td><td>N/A</td></tr> <tr><td>Candidate Mussels</td><td>No</td><td>N/A</td></tr> <tr><td>Sturgeon C.H.</td><td>No</td><td>N/A</td></tr> </tbody> </table>				Feature	Within Range	Descriptive Field	303(d)	No	N/A	Wetland Species	No	N/A	Rare and Imperiled	No	N/A	Land Use/Cover	No	N/A	Candidate Mussels	No	N/A	Sturgeon C.H.	No	N/A

Notes: High sediment load from DS outlet.
