Shoal River			ok-0422-005		Severity Score 2	
<u>Common:</u> 4.5mi SE of Crestview <u>Drainage:</u> Yellow River <u>GPS:</u> 30.70517488, -86.533003383 <u>Land owner:</u> Haiseal Timber Co			<u>County:</u> Okaloosa <u>PLSS:</u> 2N-23W-3 <u>Parcel No.:</u> 1		<u>State:</u> Florida

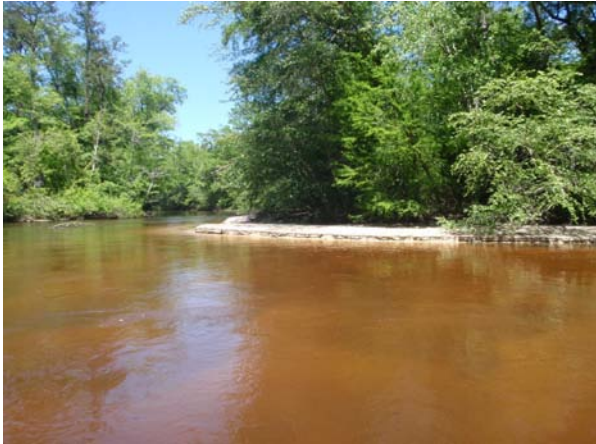
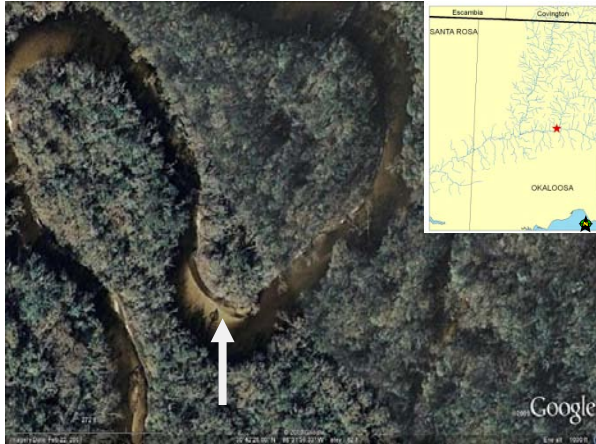
Notes: Extremely shallow section of the river.

This sediment bar extents very far into the channel, leaving little room for the thalweg.
