Pine Log Creek			ok-1106-001		Severity Score 7
<u>Common:</u> 11.5mi NE of Crestview, 0.17mi S Lumber Ridge Rd <u>Drainage:</u> Shoal River <u>GPS:</u> 30.834270512, -86.395643623 <u>Land owner:</u> Parke Lexington II- Gainesville LTD			<u>County:</u> Okaloosa <u>State:</u> Florida <u>PLSS(T-R-S):</u> 4N-22W-24 <u>Parcel No.:</u> 2.001A

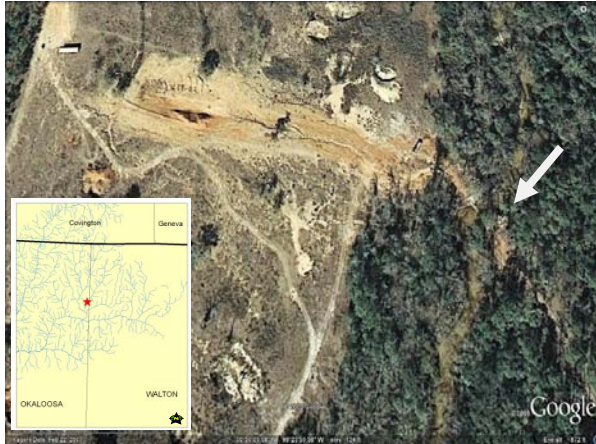
Notes: Borrow pit/ logging operation runoff entering Pine Log Creek.

Historical photos show extensive clear cutting and development of borrow pits.

DS shows change to point bar development.
