Yellow River		co-1102-r-001	Sedimentation Risk Index 48																																																																		
<u>Common:</u> 1.8mi SW of Five Points <u>Drainage:</u> Blackwater Bay <u>GPS:</u> 31.428717623,-86.330150140 <u>Land owner:</u> Royce & Barbara Harrison-US, W&T Mitchell –DS East, Lucky Hack – DS West		<u>County:</u> Covington <u>State:</u> Alabama <u>PLSS (T-R-S):</u> 6N-17E-35 <u>Parcel No.:</u> Unknown <u>Road Name:</u> Prestwood Rd

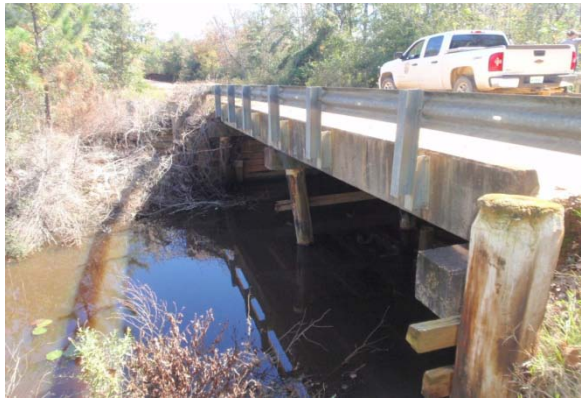
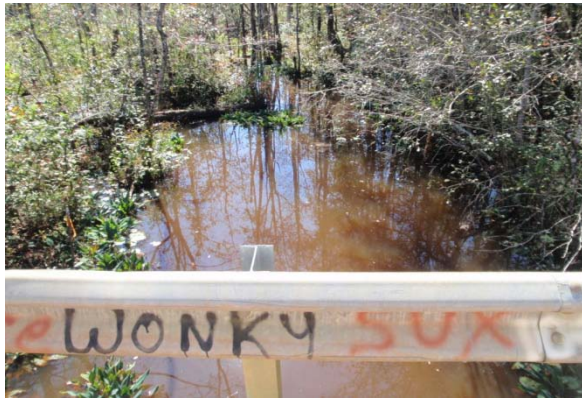
Crossing Structure: US		DS																																																																			
<table border="1"> <thead> <tr> <th>Risk Factor</th> <th>Ranking</th> <th>Score</th> </tr> </thead> <tbody> <tr><td>US Channel Morph</td><td>BEAVER DAM</td><td>3</td></tr> <tr><td>DS Channel Morph</td><td>WETLAND</td><td>5</td></tr> <tr><td>DS Bank Alteration</td><td>MINOR/PARTIAL</td><td>3</td></tr> <tr><td>Upstream Skew Angle</td><td><5°</td><td>5</td></tr> <tr><td>Crossing fill condition</td><td>Fair/Rip Rap</td><td>3</td></tr> <tr><td>Inlet/Outlet Condition</td><td>No Impairment</td><td>5</td></tr> <tr><td>Road Approach Material</td><td>All Sand/Clay</td><td>3</td></tr> <tr><td>Potential Eroded Volume Mean</td><td>21-40 y³</td><td>3</td></tr> <tr><td>Approach Slope Mean</td><td><2%</td><td>5</td></tr> <tr><td>Soil K Factor</td><td><0.20</td><td>5</td></tr> <tr><td>Upstream Rt Outlet</td><td>Vegetated</td><td>1</td></tr> <tr><td>Upstream Lt Outlet</td><td>Vegetated</td><td>1</td></tr> <tr><td>Upstream Rt Ditch</td><td>Bare soil</td><td>0</td></tr> <tr><td>Upstream Lt Ditch</td><td>Vegetated</td><td>1</td></tr> <tr><td>Downstream Rt Outlet</td><td>Vegetated</td><td>1</td></tr> <tr><td>Downstream Lt Outlet</td><td>Vegetated</td><td>1</td></tr> <tr><td>Downstream Rt Ditch</td><td>Bare soil</td><td>0</td></tr> <tr><td>Downstream Lt Ditch</td><td>Bare soil</td><td>0</td></tr> <tr><td>Outlet Total</td><td>Improved Outlet System</td><td>5</td></tr> <tr><td>Ditches Total</td><td>Partially Improved Drainage System</td><td>3</td></tr> <tr><td>SRI Total</td><td>Low Risk</td><td>48</td></tr> </tbody> </table>		Risk Factor	Ranking	Score	US Channel Morph	BEAVER DAM	3	DS Channel Morph	WETLAND	5	DS Bank Alteration	MINOR/PARTIAL	3	Upstream Skew Angle	<5°	5	Crossing fill condition	Fair/Rip Rap	3	Inlet/Outlet Condition	No Impairment	5	Road Approach Material	All Sand/Clay	3	Potential Eroded Volume Mean	21-40 y ³	3	Approach Slope Mean	<2%	5	Soil K Factor	<0.20	5	Upstream Rt Outlet	Vegetated	1	Upstream Lt Outlet	Vegetated	1	Upstream Rt Ditch	Bare soil	0	Upstream Lt Ditch	Vegetated	1	Downstream Rt Outlet	Vegetated	1	Downstream Lt Outlet	Vegetated	1	Downstream Rt Ditch	Bare soil	0	Downstream Lt Ditch	Bare soil	0	Outlet Total	Improved Outlet System	5	Ditches Total	Partially Improved Drainage System	3	SRI Total	Low Risk	48
