Reedy Creek		ok-0512-r-003		Sedimentation Risk Index 34																																																																			
<u>Common:</u> 8.9mi N of Crestview <u>Drainage:</u> Yellow River <u>GPS:</u> 30.887350, -86.598839 <u>Land owner:</u> Mark Davis-DS, Mary Keeling- US		<u>County:</u> Okaloosa <u>PLSS(T-R-S):</u> 5N-24-36 <u>Parcel No.:</u> 7.002, 7.0 <u>Road Name:</u> Old River Rd		<u>State:</u> Florida

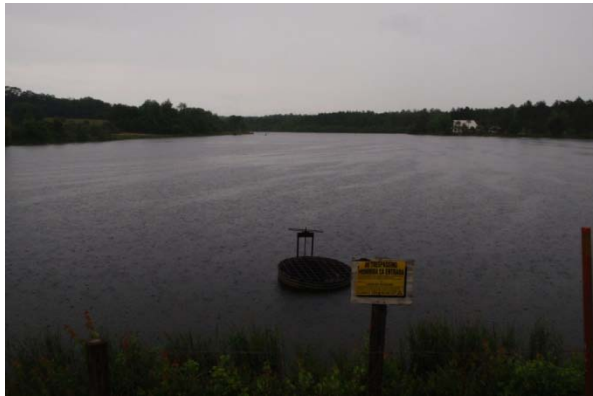
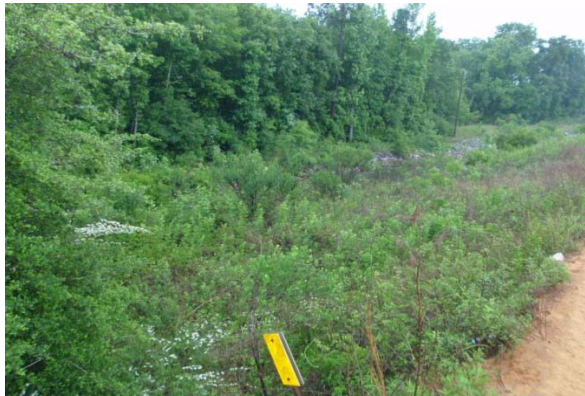
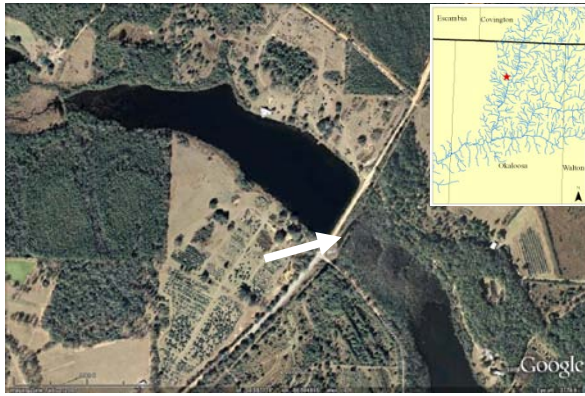
Crossing Structure: US		DS																																																																					
<table border="1"> <thead> <tr> <th>Risk Factor</th> <th>Ranking</th> <th>Score</th> </tr> </thead> <tbody> <tr><td>US Channel Morph</td><td>PONDED</td><td>1</td></tr> <tr><td>DS Channel Morph</td><td>PONDED</td><td>1</td></tr> <tr><td>DS Bank Alteration</td><td>HIGH</td><td>1</td></tr> <tr><td>Upstream Skew Angle</td><td><5°</td><td>5</td></tr> <tr><td>Crossing fill condition</td><td>Good/Vegetated</td><td>5</td></tr> <tr><td>Inlet/Outlet Condition</td><td>No Impairment</td><td>5</td></tr> <tr><td>Road Approach Material</td><td>All Sand/Clay</td><td>3</td></tr> <tr><td>Potential Eroded Volume Mean</td><td>>40 y³</td><td>1</td></tr> <tr><td>Approach Slope Mean</td><td>>4%</td><td>1</td></tr> <tr><td>Soil K Factor</td><td><0.20</td><td>5</td></tr> <tr><td>Upstream Rt Outlet</td><td>Vegetated</td><td>1</td></tr> <tr><td>Upstream Lt Outlet</td><td>Vegetated</td><td>1</td></tr> <tr><td>Upstream Rt Ditch</td><td>Bare soil</td><td>0</td></tr> <tr><td>Upstream Lt Ditch</td><td>Bare soil</td><td>0</td></tr> <tr><td>Downstream Rt Outlet</td><td>Rip Rap</td><td>1</td></tr> <tr><td>Downstream Lt Outlet</td><td>Vegetated</td><td>1</td></tr> <tr><td>Downstream Rt Ditch</td><td>Bare soil</td><td>0</td></tr> <tr><td>Downstream Lt Ditch</td><td>Bare soil</td><td>0</td></tr> <tr><td>Outlet Total</td><td>Improved Outlet System</td><td>5</td></tr> <tr><td>Ditches Total</td><td>Unimproved Drainage System</td><td>1</td></tr> <tr><td>SRI Total</td><td>High Risk</td><td>34</td></tr> </tbody> </table>		Risk Factor	Ranking	Score	US Channel Morph	PONDED	1	DS Channel Morph	PONDED	1	DS Bank Alteration	HIGH	1	Upstream Skew Angle	<5°	5	Crossing fill condition	Good/Vegetated	5	Inlet/Outlet Condition	No Impairment	5	Road Approach Material	All Sand/Clay	3	Potential Eroded Volume Mean	>40 y ³	1	Approach Slope Mean	>4%	1	Soil K Factor	<0.20	5	Upstream Rt Outlet	Vegetated	1	Upstream Lt Outlet	Vegetated	1	Upstream Rt Ditch	Bare soil	0	Upstream Lt Ditch	Bare soil	0	Downstream Rt Outlet	Rip Rap	1	Downstream Lt Outlet	Vegetated	1	Downstream Rt Ditch	Bare soil	0	Downstream Lt Ditch	Bare soil	0	Outlet Total	Improved Outlet System	5	Ditches Total	Unimproved Drainage System	1	SRI Total	High Risk	34

Notes: Rt approach paved to hilltop. Fish passage barrier. Second stand pipe US adjacent to Rt approach
