Hog Foot Creek		co-0810-r-018	Sedimentation Risk Index <b>40</b>																																																																		
<u>Common:</u> 9.8mi S of Andalusia <u>Drainage:</u> Five Runs Creek <u>GPS:</u> 31.168303, -86.519333 <u>Land owner:</u> USA-Conecuh Nat. Forest		<u>County:</u> Covington <u>State:</u> Alabama <u>PLSS (T-R-S):</u> 2N-15E-2 <u>Parcel No.:</u> 5 <u>Road Name:</u> Hog Foot Rd

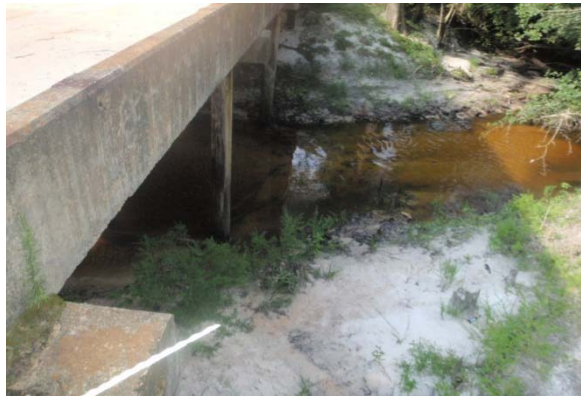
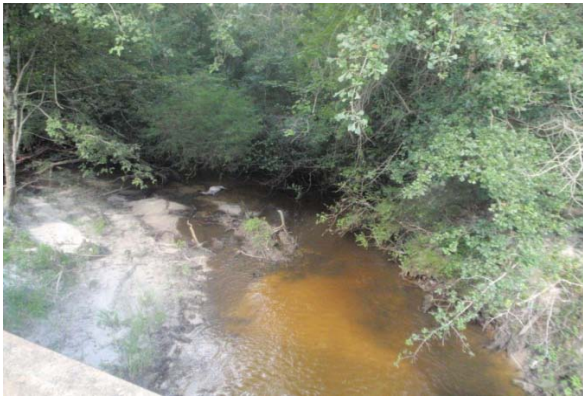
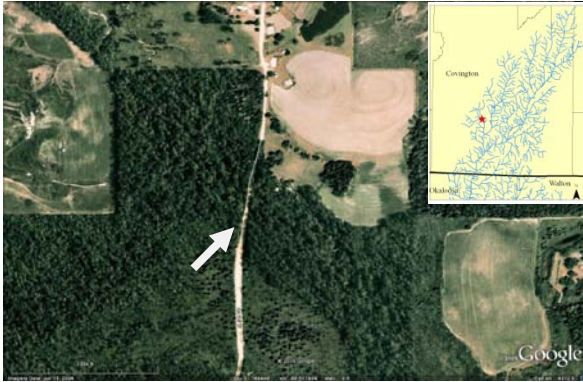
Crossing Structure: DS		DS																																																																			
<table border="1"> <thead> <tr> <th>Risk Factor</th> <th>Ranking</th> <th>Score</th> </tr> </thead> <tbody> <tr><td>US Channel Morph</td><td>C</td><td>5</td></tr> <tr><td>DS Channel Morph</td><td>DA</td><td>3</td></tr> <tr><td>DS Bank Alteration</td><td>HIGH</td><td>1</td></tr> <tr><td>Upstream Skew Angle</td><td>5-30°</td><td>3</td></tr> <tr><td>Crossing fill condition</td><td>Poor/Bare soil</td><td>1</td></tr> <tr><td>Inlet/Outlet Condition</td><td>Sed Islands/Scouring</td><td>3</td></tr> <tr><td>Road Approach Material</td><td>All Sand/Clay</td><td>3</td></tr> <tr><td>Potential Eroded Volume Mean</td><td>&lt;21 y<sup>3</sup></td><td>5</td></tr> <tr><td>Approach Slope Mean</td><td>&lt;2%</td><td>5</td></tr> <tr><td>Soil K Factor</td><td>&lt;0.20</td><td>5</td></tr> <tr><td>Upstream Rt Outlet</td><td>Bare soil</td><td>0</td></tr> <tr><td>Upstream Lt Outlet</td><td>Vegetated</td><td>1</td></tr> <tr><td>Upstream Rt Ditch</td><td>Vegetated</td><td>1</td></tr> <tr><td>Upstream Lt Ditch</td><td>Bare soil</td><td>0</td></tr> <tr><td>Downstream Rt Outlet</td><td>Vegetated</td><td>1</td></tr> <tr><td>Downstream Lt Outlet</td><td>Bare soil</td><td>0</td></tr> <tr><td>Downstream Rt Ditch</td><td>Vegetated</td><td>1</td></tr> <tr><td>Downstream Lt Ditch</td><td>Vegetated</td><td>1</td></tr> <tr><td>Outlet Total</td><td>Partially Improved Outlet System</td><td>3</td></tr> <tr><td>Ditches Total</td><td>Partially Improved Drainage System</td><td>3</td></tr> <tr><td><b>SRI Total</b></td><td><b>Medium Risk</b></td><td><b>40</b></td></tr> </tbody> </table>		Risk Factor	Ranking	Score	US Channel Morph	C	5	DS Channel Morph	DA	3	DS Bank Alteration	HIGH	1	Upstream Skew Angle	5-30°	3	Crossing fill condition	Poor/Bare soil	1	Inlet/Outlet Condition	Sed Islands/Scouring	3	Road Approach Material	All Sand/Clay	3	Potential Eroded Volume Mean	<21 y <sup>3</sup>	5	Approach Slope Mean	<2%	5	Soil K Factor	<0.20	5	Upstream Rt Outlet	Bare soil	0	Upstream Lt Outlet	Vegetated	1	Upstream Rt Ditch	Vegetated	1	Upstream Lt Ditch	Bare soil	0	Downstream Rt Outlet	Vegetated	1	Downstream Lt Outlet	Bare soil	0	Downstream Rt Ditch	Vegetated	1	Downstream Lt Ditch	Vegetated	1	Outlet Total	Partially Improved Outlet System	3	Ditches Total	Partially Improved Drainage System	3	<b>SRI Total</b>	<b>Medium Risk</b>	<b>40</b>

Notes: Culvert approx. 150 ft north of the bridge crossing. Dry and rip rap-filled.
