Shoal River			ok-0422-007		Severity Score 5.5	
<u>Common:</u> 4.7mi SE of Crestview <u>Drainage:</u> Yellow River <u>GPS:</u> 30.695776786, -86.544244906 <u>Land owner:</u> RB: Haiseal Timber Co/ LB: Newman & Julie Bush			<u>County:</u> Okaloosa <u>PLSS(T-R-S):</u> 2N-23W-4 <u>Parcel No.:</u> 3/3.001		<u>State:</u> Florida

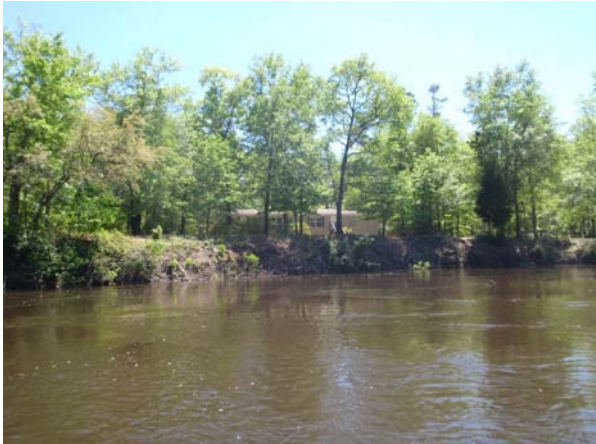
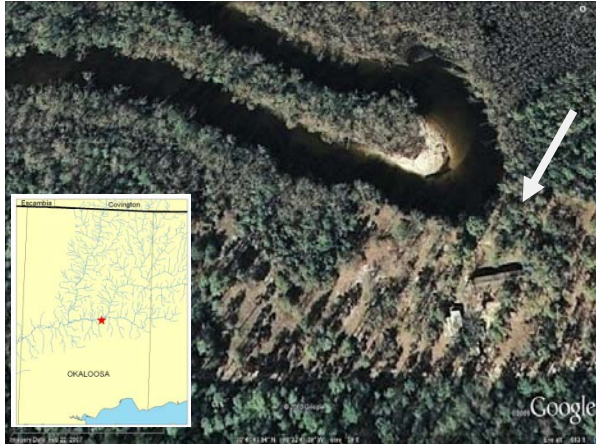
Notes: Pipe Discharge coming from a PVC pipe on the left bank upstream from this site.
