Unnamed tributary		co-0907-r-003	Sedimentation Risk Index 42																																																																		
<u>Common:</u> 7.1mi NW of Opp <u>Drainage:</u> Yellow River <u>GPS:</u> 31.320859074, -86.367395487 <u>Land owner:</u> Bonnie Worley, Tr. -US, Roy Jr. & Sybil Weaver -DS		<u>County:</u> Covington <u>State:</u> Alabama <u>PLSS (T-R-S):</u> 4N-17E-17 <u>Parcel No.:</u> 2; 1 <u>Road Name:</u> Old Dragstrip Rd

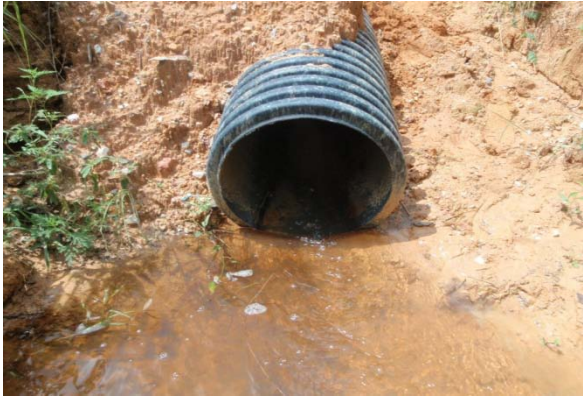
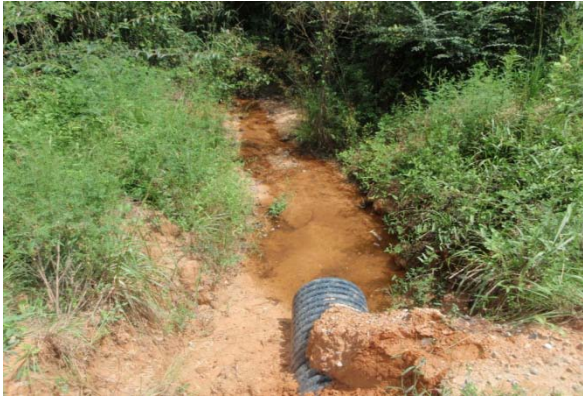
Crossing Structure: DS		DS																																																																			
<table border="1"> <thead> <tr> <th>Risk Factor</th> <th>Ranking</th> <th>Score</th> </tr> </thead> <tbody> <tr><td>US Channel Morph</td><td>WETLAND</td><td>5</td></tr> <tr><td>DS Channel Morph</td><td>B</td><td>5</td></tr> <tr><td>DS Bank Alteration</td><td>MINOR/PARTIAL</td><td>3</td></tr> <tr><td>Upstream Skew Angle</td><td><5°</td><td>5</td></tr> <tr><td>Crossing fill condition</td><td>Poor/Bare soil</td><td>1</td></tr> <tr><td>Inlet/Outlet Condition</td><td>Sed Islands/Scouring</td><td>3</td></tr> <tr><td>Road Approach Material</td><td>All Sand/Clay</td><td>3</td></tr> <tr><td>Potential Eroded Volume Mean</td><td><21 y³</td><td>5</td></tr> <tr><td>Approach Slope Mean</td><td>2.1-4%</td><td>3</td></tr> <tr><td>Soil K Factor</td><td><0.20</td><td>5</td></tr> <tr><td>Upstream Rt Outlet</td><td>Bare soil</td><td>0</td></tr> <tr><td>Upstream Lt Outlet</td><td>Bare soil</td><td>0</td></tr> <tr><td>Upstream Rt Ditch</td><td>Bare soil</td><td>0</td></tr> <tr><td>Upstream Lt Ditch</td><td>Bare soil</td><td>0</td></tr> <tr><td>Downstream Rt Outlet</td><td>Vegetated</td><td>1</td></tr> <tr><td>Downstream Lt Outlet</td><td>Vegetated</td><td>1</td></tr> <tr><td>Downstream Rt Ditch</td><td>Bare soil</td><td>0</td></tr> <tr><td>Downstream Lt Ditch</td><td>Bare soil</td><td>0</td></tr> <tr><td>Outlet Total</td><td>Partially Improved Outlet System</td><td>3</td></tr> <tr><td>Ditches Total</td><td>Unimproved Drainage System</td><td>1</td></tr> <tr><td>SRI Total</td><td>Medium Risk</td><td>42</td></tr> </tbody> </table>				Risk Factor	Ranking	Score	US Channel Morph	WETLAND	5	DS Channel Morph	B	5	DS Bank Alteration	MINOR/PARTIAL	3	Upstream Skew Angle	<5°	5	Crossing fill condition	Poor/Bare soil	1	Inlet/Outlet Condition	Sed Islands/Scouring	3	Road Approach Material	All Sand/Clay	3	Potential Eroded Volume Mean	<21 y ³	5	Approach Slope Mean	2.1-4%	3	Soil K Factor	<0.20	5	Upstream Rt Outlet	Bare soil	0	Upstream Lt Outlet	Bare soil	0	Upstream Rt Ditch	Bare soil	0	Upstream Lt Ditch	Bare soil	0	Downstream Rt Outlet	Vegetated	1	Downstream Lt Outlet	Vegetated	1	Downstream Rt Ditch	Bare soil	0	Downstream Lt Ditch	Bare soil	0	Outlet Total	Partially Improved Outlet System	3	Ditches Total	Unimproved Drainage System	1	SRI Total	Medium Risk	42

Notes: Excessive erosion over culvert.
