Unnamed tributary		ok-0429-r-012	Sedimentation Risk Index 26																																																																		
<u>Common:</u> 6.2mi SW of Laurel Hill <u>Drainage:</u> Murder Creek <u>GPS:</u> 30.894997, -86.535436 <u>Land owner:</u> Ralph & Carolyn Lunsford		<u>County:</u> Okaloosa <u>State:</u> Florida <u>PLSS(T-R-S):</u> 5N-23-34 <u>Parcel No.:</u> 2.002 <u>Road Name:</u> Jack Rd

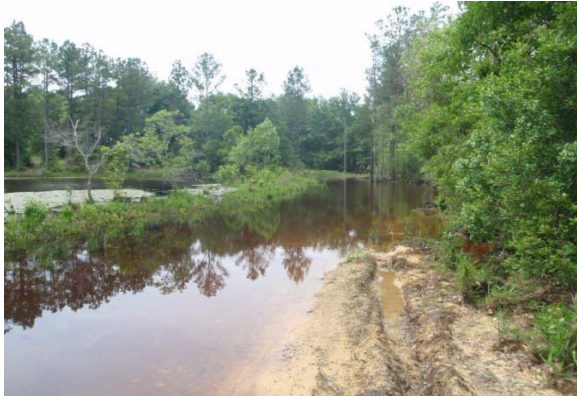
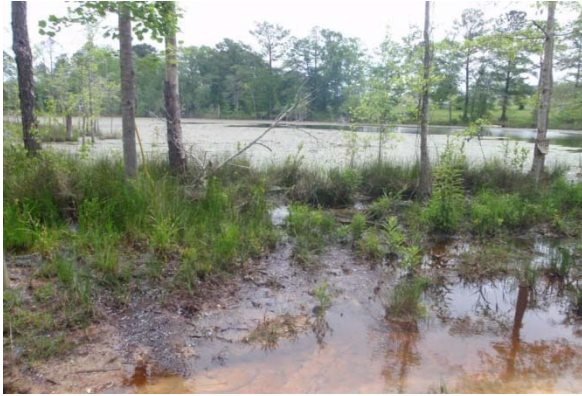
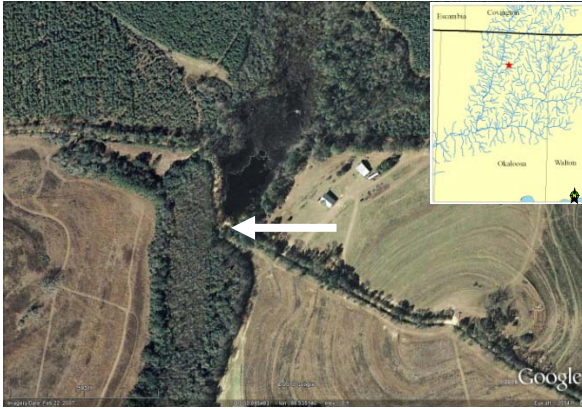
Crossing Structure: From Rt Approach		US																																																																			
<table border="1"> <thead> <tr> <th>Risk Factor</th> <th>Ranking</th> <th>Score</th> </tr> </thead> <tbody> <tr><td>US Channel Morph</td><td>PONDED</td><td>1</td></tr> <tr><td>DS Channel Morph</td><td>WETLAND</td><td>5</td></tr> <tr><td>DS Bank Alteration</td><td>HIGH</td><td>1</td></tr> <tr><td>Upstream Skew Angle</td><td><5°</td><td>5</td></tr> <tr><td>Crossing fill condition</td><td>Poor/Bare soil</td><td>1</td></tr> <tr><td>Inlet/Outlet Condition</td><td>Blocked</td><td>1</td></tr> <tr><td>Road Approach Material</td><td>All Sand/Clay</td><td>3</td></tr> <tr><td>Potential Eroded Volume Mean</td><td>>40 y³</td><td>1</td></tr> <tr><td>Approach Slope Mean</td><td>>4%</td><td>1</td></tr> <tr><td>Soil K Factor</td><td><0.20</td><td>5</td></tr> <tr><td>Upstream Rt Outlet</td><td>Bare soil</td><td>0</td></tr> <tr><td>Upstream Lt Outlet</td><td>Bare soil</td><td>0</td></tr> <tr><td>Upstream Rt Ditch</td><td>Bare soil</td><td>0</td></tr> <tr><td>Upstream Lt Ditch</td><td>Bare soil</td><td>0</td></tr> <tr><td>Downstream Rt Outlet</td><td>Bare soil</td><td>0</td></tr> <tr><td>Downstream Lt Outlet</td><td>Bare soil</td><td>0</td></tr> <tr><td>Downstream Rt Ditch</td><td>Bare soil</td><td>0</td></tr> <tr><td>Downstream Lt Ditch</td><td>Bare soil</td><td>0</td></tr> <tr><td>Outlet Total</td><td>Unimproved Outlet System</td><td>1</td></tr> <tr><td>Ditches Total</td><td>Unimproved Drainage System</td><td>1</td></tr> <tr><td>SRI Total</td><td>High Risk</td><td>26</td></tr> </tbody> </table>		Risk Factor	Ranking	Score	US Channel Morph	PONDED	1	DS Channel Morph	WETLAND	5	DS Bank Alteration	HIGH	1	Upstream Skew Angle	<5°	5	Crossing fill condition	Poor/Bare soil	1	Inlet/Outlet Condition	Blocked	1	Road Approach Material	All Sand/Clay	3	Potential Eroded Volume Mean	>40 y ³	1	Approach Slope Mean	>4%	1	Soil K Factor	<0.20	5	Upstream Rt Outlet	Bare soil	0	Upstream Lt Outlet	Bare soil	0	Upstream Rt Ditch	Bare soil	0	Upstream Lt Ditch	Bare soil	0	Downstream Rt Outlet	Bare soil	0	Downstream Lt Outlet	Bare soil	0	Downstream Rt Ditch	Bare soil	0	Downstream Lt Ditch	Bare soil	0	Outlet Total	Unimproved Outlet System	1	Ditches Total	Unimproved Drainage System	1	SRI Total	High Risk	26

Notes: Unknown crossing type- Flooded when accessed 2 different days.
