| Shoal River | | | ok-0423-008 | | Severity Score 2.5 | |
| <u>Common:</u> 3.7mi SE of Crestview, .10mi Upstream of I-10 bridge <u>Drainage:</u> Yellow River <u>GPS:</u> 30.728122, -86.521925 <u>Land owner:</u> Haiseal Timber Co | | | <u>County:</u> Okaloosa <u>PLSS:</u> 3N-23W-26 <u>Parcel No.:</u> 9 | | <u>State:</u> Florida | |

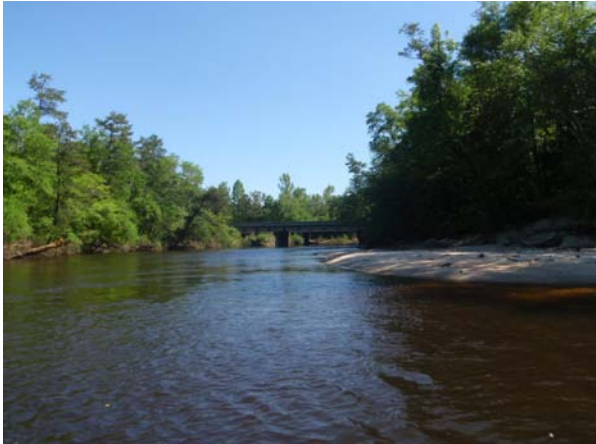
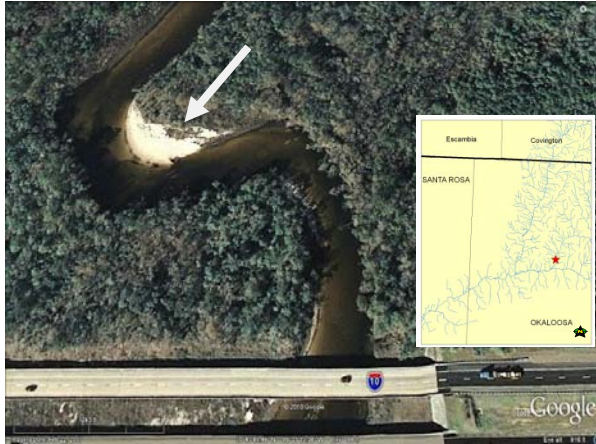
| Shoal River | | | ok-0423-008 | | Severity Score 2.5 | |
|--|---|---|---|---|--|--|
| RB | | | | | | |

| Shoal River | | | ok-0423-008 | | Severity Score 2.5 | |
|--|---|---|---|---|--|--|
| Channel Stability | Poor | 1.5 | 303(d) | No | N/A | |
| BEHI | High | 1 | Land Use/Cover | Yes | N/A / STREAMS AND WATERWAYS | |

Notes: Aggradational site.
