Good Springs Creek		co-1102-r-005	Sedimentation Risk Index 44																																																																		
<u>Common:</u> 2.0mi S of Five Points <u>Drainage:</u> Poley Creek <u>GPS:</u> 31.410927205,-86.301856745 <u>Land owner:</u> Charles & Stacy Hinds		<u>County:</u> Covington <u>State:</u> Alabama <u>PLSS (T-R-S):</u> 5N-17E-12 <u>Parcel No.:</u> 1 <u>Road Name:</u> Chalker Rd

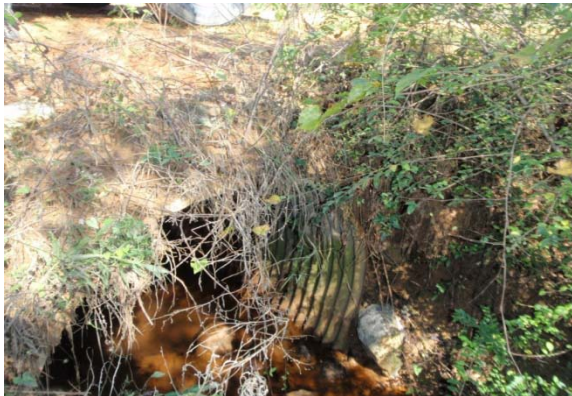
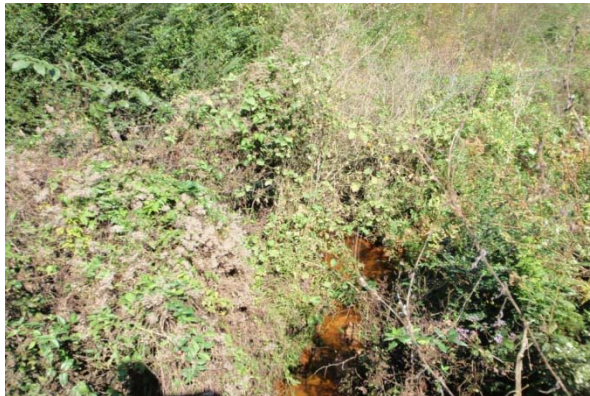
Risk Factor	Ranking	Score																																																																			
US Channel Morph	C	5																																																																			
DS Channel Morph	C	5																																																																			
DS Bank Alteration	MINOR/PARTIAL	3																																																																			
Upstream Skew Angle	<5°	5																																																																			
Crossing fill condition	Good/Vegetated	5																																																																			
Inlet/Outlet Condition	No Impairment	5																																																																			
Road Approach Material	All Sand/Clay	3																																																																			
Potential Eroded Volume Mean	>40 y ³	1																																																																			
Approach Slope Mean	2.1-4%	3

Soil K Factor	0.21-0.40	3																																																																			
Upstream Rt Outlet	Vegetated	1																																																																			
Upstream Lt Outlet	Vegetated	1																																																																			
Upstream Rt Ditch	Bare soil	0																																																																			
Upstream Lt Ditch	Bare soil	0																																																																			
Downstream Rt Outlet	Vegetated	1																																																																			
Downstream Lt Outlet	Vegetated	1																																																																			
Downstream Rt Ditch	Bare soil	0																																																																			
Downstream Lt Ditch	Bare soil	0																																																																			
Outlet Total	Improved Outlet System	5

Ditches Total	Unimproved Drainage System	1																																																																			
SRI Total	Medium Risk	44
