Yellow River		co-0805-001	Severity Score 1.75																																																																																
<u>Common:</u> 10.7mi NW of Florala <u>Drainage:</u> Blackwater Bay <u>GPS:</u> 31.087333225, -86.483012892 <u>Land owner:</u> RB: USA / LB: James & Patricia Battles		<u>County:</u> Covington <u>State:</u> Alabama <u>PLSS:</u> 1N-16E-6 <u>Parcel No.:</u> 2/1

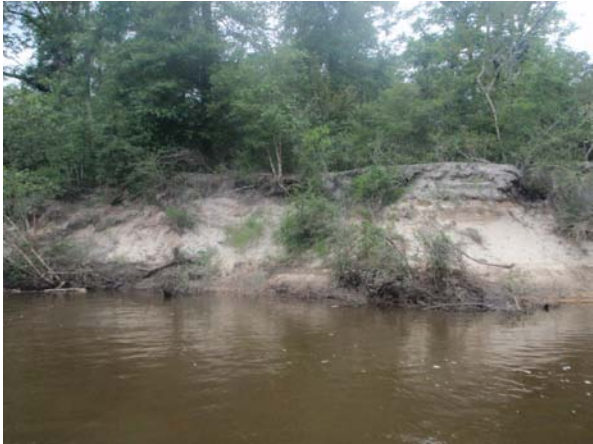
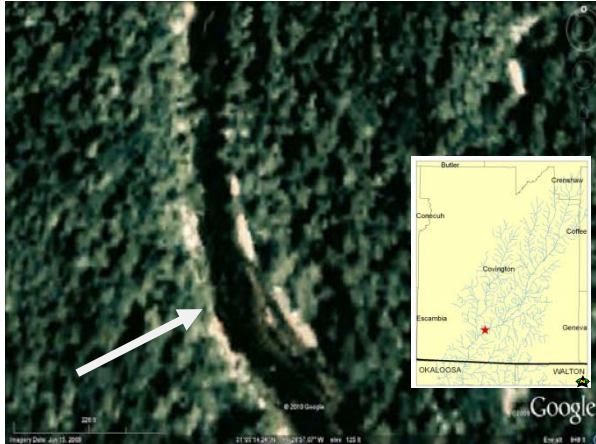
Notes: Some bank erosion apparent, possibly natural meander bend.
