Unnamed tributary		wa-0625-r-006	Sedimentation Risk Index 28																																																																		
<u>Common:</u> 2.8mi SW of Florala <u>Drainage:</u> Fleming Creek <u>GPS:</u> 30.994142, -86.373522 <u>Land owner:</u> James & Barbara Craig- DS, S.G. & Betty Hargrove Sr.- US		<u>County:</u> Walton <u>State:</u> Florida <u>PLSS(T-R-S):</u> 6N-21-20/29 <u>Parcel No.:</u> 1; 2 <u>Road Name:</u> Franklin Rd

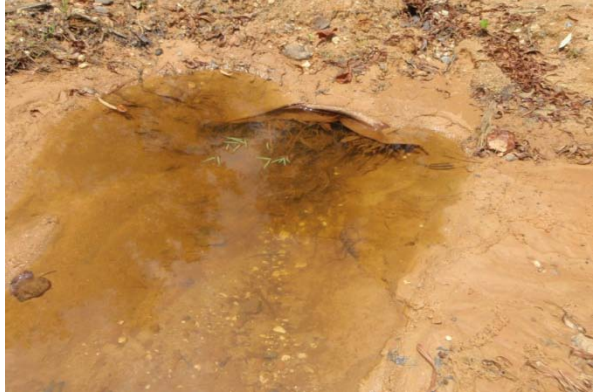
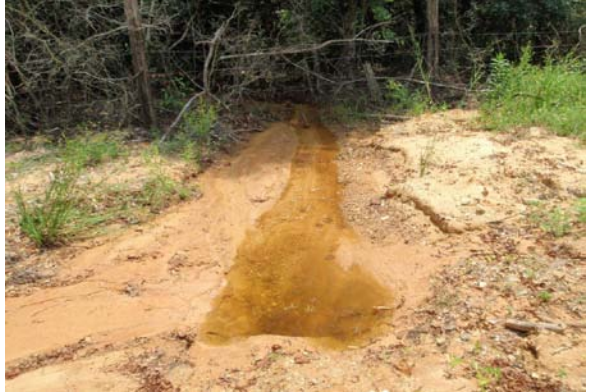
Crossing Structure: US		DS																																																																			
<table border="1"> <thead> <tr> <th>Risk Factor</th> <th>Ranking</th> <th>Score</th> </tr> </thead> <tbody> <tr><td>US Channel Morph</td><td>PONDED</td><td>1</td></tr> <tr><td>DS Channel Morph</td><td>PONDED</td><td>1</td></tr> <tr><td>DS Bank Alteration</td><td>MINOR/PARTIAL</td><td>3</td></tr> <tr><td>Upstream Skew Angle</td><td>>30°</td><td>1</td></tr> <tr><td>Crossing fill condition</td><td>Poor/Bare soil</td><td>1</td></tr> <tr><td>Inlet/Outlet Condition</td><td>Blocked</td><td>1</td></tr> <tr><td>Road Approach Material</td><td>All Sand/Clay</td><td>3</td></tr> <tr><td>Potential Eroded Volume Mean</td><td>21-40 y³</td><td>3</td></tr> <tr><td>Approach Slope Mean</td><td>2.1-4%</td><td>3</td></tr> <tr><td>Soil K Factor</td><td><0.20</td><td>5</td></tr> <tr><td>Upstream Rt Outlet</td><td>Vegetated</td><td>1</td></tr> <tr><td>Upstream Lt Outlet</td><td>Vegetated</td><td>1</td></tr> <tr><td>Upstream Rt Ditch</td><td>Bare soil</td><td>0</td></tr> <tr><td>Upstream Lt Ditch</td><td>Bare soil</td><td>0</td></tr> <tr><td>Downstream Rt Outlet</td><td>Vegetated</td><td>1</td></tr> <tr><td>Downstream Lt Outlet</td><td>Vegetated</td><td>1</td></tr> <tr><td>Downstream Rt Ditch</td><td>Bare soil</td><td>0</td></tr> <tr><td>Downstream Lt Ditch</td><td>Bare soil</td><td>0</td></tr> <tr><td>Outlet Total</td><td>Improved Outlet System</td><td>5</td></tr> <tr><td>Ditches Total</td><td>Unimproved Drainage System</td><td>1</td></tr> <tr><td>SRI Total</td><td>High Risk</td><td>28</td></tr> </tbody> </table>				Risk Factor	Ranking	Score	US Channel Morph	PONDED	1	DS Channel Morph	PONDED	1	DS Bank Alteration	MINOR/PARTIAL	3	Upstream Skew Angle	>30°	1	Crossing fill condition	Poor/Bare soil	1	Inlet/Outlet Condition	Blocked	1	Road Approach Material	All Sand/Clay	3	Potential Eroded Volume Mean	21-40 y ³	3	Approach Slope Mean	2.1-4%	3	Soil K Factor	<0.20	5	Upstream Rt Outlet	Vegetated	1	Upstream Lt Outlet	Vegetated	1	Upstream Rt Ditch	Bare soil	0	Upstream Lt Ditch	Bare soil	0	Downstream Rt Outlet	Vegetated	1	Downstream Lt Outlet	Vegetated	1	Downstream Rt Ditch	Bare soil	0	Downstream Lt Ditch	Bare soil	0	Outlet Total	Improved Outlet System	5	Ditches Total	Unimproved Drainage System	1	SRI Total	High Risk	28

Notes: Draining agricultural pond US
