Yellow River			ok-0319-002		Severity Score 3.75	
<u>Common:</u> 7.4mi SW of Crestview <u>Drainage:</u> Blackwater Bay <u>GPS:</u> 30.680552, -86.651965 <u>Land owner:</u> USA- Eglin AFB			<u>County:</u> Okaloosa <u>PLSS(T-R-S):</u> 2N-16W-16 <u>Parcel No.:</u> 1		<u>State:</u> Florida

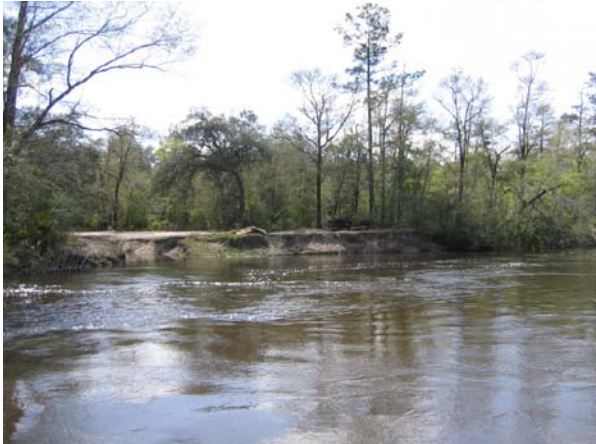
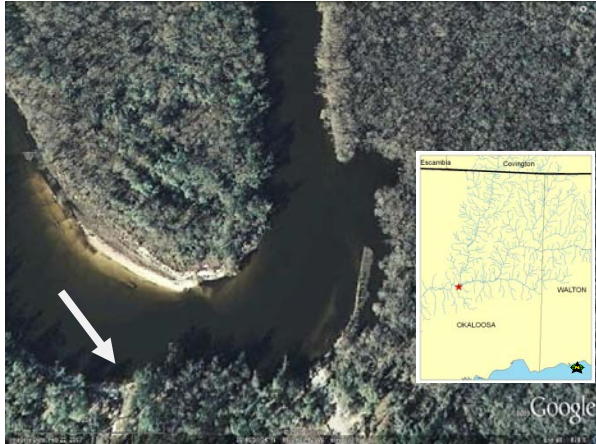
Notes: Eglin AFB Gin Hole Landing recreational site. Found shotgun shells on the bank. Scar of improvised boat launch? Evidence of camp fires. Top of LB is clear.
