Shoal River			ok-0423-001		Severity Score 11
<u>Common:</u> 3.6mi E of Crestview, .01mi S of Hwy 90 <u>Drainage:</u> Yellow River <u>GPS:</u> 30.751625588,-86.510107894 <u>Land owner:</u> RB: G.W. McLean Jr. LB: E. Aycock Jr./ K. & W. Manring/R. W. Alter/ R. Ward & L. Weasley/ JRW Investments LLC			<u>County:</u> Okaloosa <u>State:</u> Florida <u>PLSS(T-R-S):</u> 3N-23W-14 <u>Parcel No.:</u> RB:2, LB:2.2/ 1.9/ 1.800/ 1.9001/ 2.2002

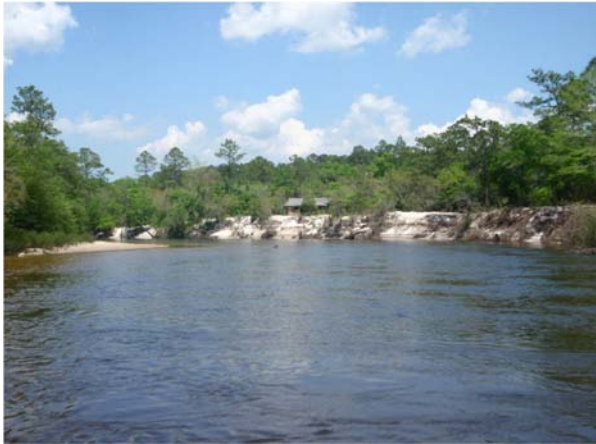
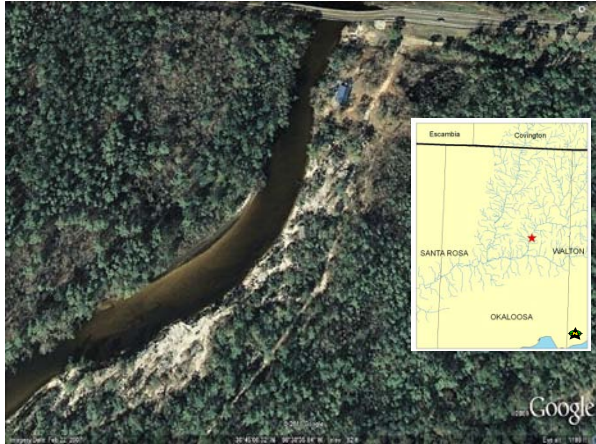
Notes: Reach length is 2043 feet long. It is characterized by a lack of a riparian buffer on the right bank as seen on the aerial photo. Shoring structures used include rip rap and concrete. County road 90 bridge and a private boat launch is also located at this location. Houses located right on top of bank, some in disrepair/abandoned.
