Shoal River		ok-0615-007		Severity Score 4.75	
<u>Common:</u> 7.7mi NE of Crestview <u>Drainage:</u> Yellow River <u>GPS:</u> 30.791181735, -86.444845391 <u>Land owner:</u> Haiseal Timber Co		<u>County:</u> Okaloosa <u>PLSS(T-R-S):</u> 3N-22W-4 <u>Parcel No.:</u> 4		<u>State:</u> Florida

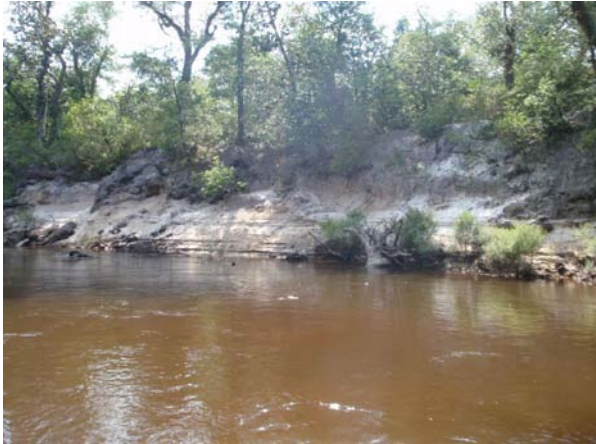
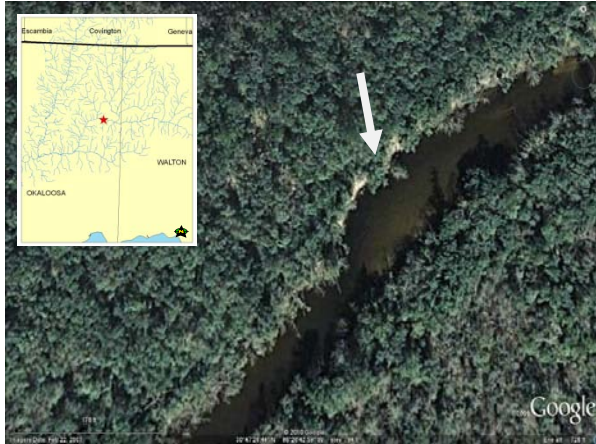
RB					
Risk Factor	Ranking	Score	Feature	Within Range	Descriptive Field
Channel Stability	Fair	1	303d	No	N/A
Channel Alteration	None	0	Wetland Species	Yes	1-3 FOCAL SPECIES IN WETLAND AREAS
Bank Erosion	Active	1	Rare and Imperiled	Yes	GOLDSTRIPE DARTER, IRONCOLOR SHINER
BEHI	High	1	Land Use/ Cover	Yes	N/A/ STREAMS AND WATERWAYS
Local NPSP	No Evidence	0	Candidate Mussels	No	N/A
Shoring Structures	Not Present	0	Sturgeon C.H.	No	N/A
Pipe Discharge	Not Present	0			
Water Odors	Not Present	0			
Fish Passage Barrier	Not Present	0			
RB: Riparian Buffer	0-29 ft	0.75			
LB: Riparian Buffer	100+ ft	0			
RB: Floodplain Access	None	0.75

Notes: Natural meander erosion.
