Indigo Creek		ok-0429-r-002	Sedimentation Risk Index <b>36</b>																																																																																							
<u>Common:</u> 4.1mi E of Holt <u>Drainage:</u> Yellow River <u>GPS:</u> 30.729581195, -86.677171871 <u>Land owner:</u> Dorothy Kennedy		<u>County:</u> Okaloosa <u>State:</u> Florida <u>PLSS(T-R-S):</u> 3N-24-30 <u>Parcel No.:</u> 6 <u>Road Name:</u> Gilmore Rd

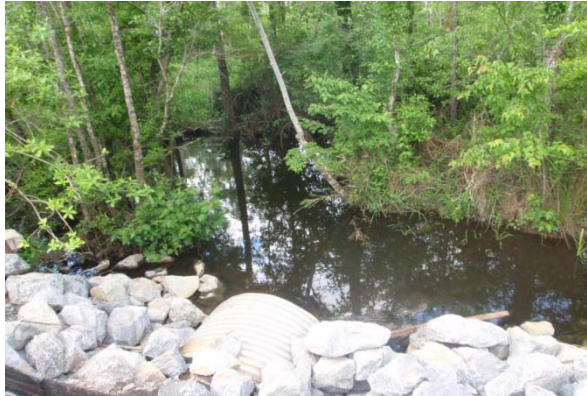
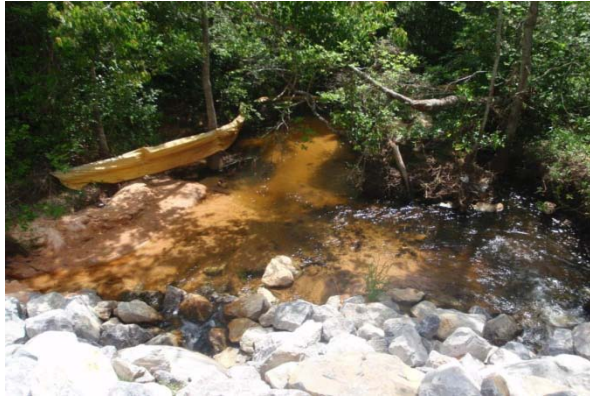
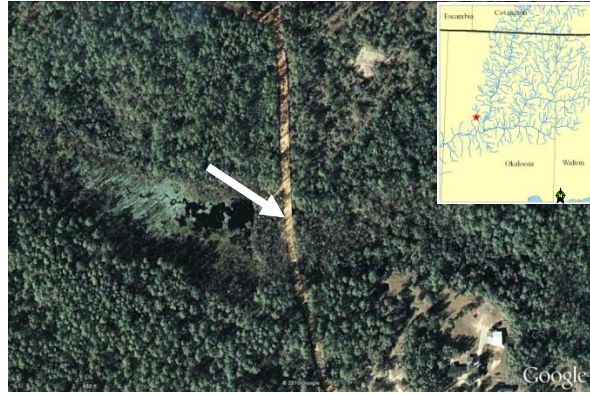
Notes: Turbidity curtain DS and silt fencing in place both US/DS. Failing BMPs.
