Unnamed tributary		wa-0707-r-005	Sedimentation Risk Index 22																																																																		
<u>Common:</u> 2.0mi NE of Mossy Head <u>Drainage:</u> Adam's Mill Creek <u>GPS:</u> 30.770678, -86.305817 <u>Land owner:</u> Richard & Monica Mason-US, Derek & Byron Rawles-DS		<u>County:</u> Walton <u>State:</u> Florida <u>PLSS(T-R-S):</u> 3N-21-12 <u>Parcel No.:</u> 2.021; 2.020 <u>Road Name:</u> Mill Creek Dr.

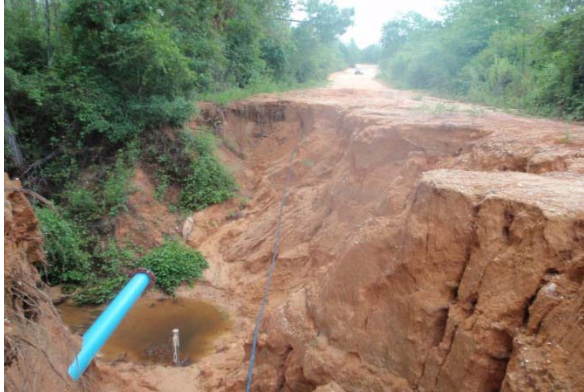
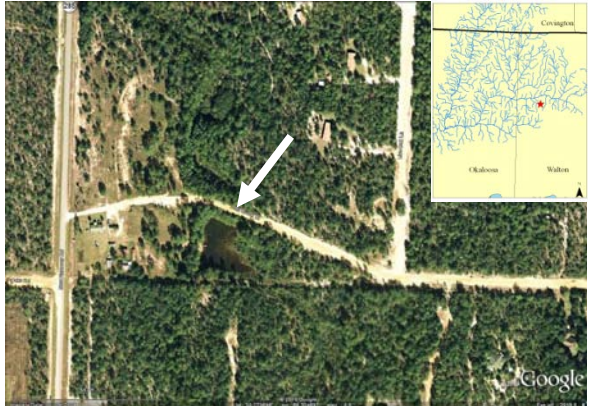
Crossing Structure: DS		US																																																																			
<table border="1"> <thead> <tr> <th>Risk Factor</th> <th>Ranking</th> <th>Score</th> </tr> </thead> <tbody> <tr><td>US Channel Morph</td><td>PONDED</td><td>1</td></tr> <tr><td>DS Channel Morph</td><td>F</td><td>1</td></tr> <tr><td>DS Bank Alteration</td><td>HIGH</td><td>1</td></tr> <tr><td>Upstream Skew Angle</td><td>>30°</td><td>1</td></tr> <tr><td>Crossing fill condition</td><td>Poor/Bare soil</td><td>1</td></tr> <tr><td>Inlet/Outlet Condition</td><td>Blocked</td><td>1</td></tr> <tr><td>Road Approach Material</td><td>All Sand/Clay</td><td>3</td></tr> <tr><td>Potential Eroded Volume Mean</td><td>>40 y³</td><td>1</td></tr> <tr><td>Approach Slope Mean</td><td>>4%</td><td>1</td></tr> <tr><td>Soil K Factor</td><td><0.20</td><td>5</td></tr> <tr><td>Upstream Rt Outlet</td><td>Vegetated</td><td>1</td></tr> <tr><td>Upstream Lt Outlet</td><td>Vegetated</td><td>1</td></tr> <tr><td>Upstream Rt Ditch</td><td>Bare soil</td><td>0</td></tr> <tr><td>Upstream Lt Ditch</td><td>Bare soil</td><td>0</td></tr> <tr><td>Downstream Rt Outlet</td><td>Vegetated</td><td>1</td></tr> <tr><td>Downstream Lt Outlet</td><td>Vegetated</td><td>1</td></tr> <tr><td>Downstream Rt Ditch</td><td>Bare soil</td><td>0</td></tr> <tr><td>Downstream Lt Ditch</td><td>Bare soil</td><td>0</td></tr> <tr><td>Outlet Total</td><td>Improved Outlet System</td><td>5</td></tr> <tr><td>Ditches Total</td><td>Unimproved Drainage System</td><td>1</td></tr> <tr><td>SRI Total</td><td>High Risk</td><td>22</td></tr> </tbody> </table>		Risk Factor	Ranking	Score	US Channel Morph	PONDED	1	DS Channel Morph	F	1	DS Bank Alteration	HIGH	1	Upstream Skew Angle	>30°	1	Crossing fill condition	Poor/Bare soil	1	Inlet/Outlet Condition	Blocked	1	Road Approach Material	All Sand/Clay	3	Potential Eroded Volume Mean	>40 y ³	1	Approach Slope Mean	>4%	1	Soil K Factor	<0.20	5	Upstream Rt Outlet	Vegetated	1	Upstream Lt Outlet	Vegetated	1	Upstream Rt Ditch	Bare soil	0	Upstream Lt Ditch	Bare soil	0	Downstream Rt Outlet	Vegetated	1	Downstream Lt Outlet	Vegetated	1	Downstream Rt Ditch	Bare soil	0	Downstream Lt Ditch	Bare soil	0	Outlet Total	Improved Outlet System	5	Ditches Total	Unimproved Drainage System	1	SRI Total	High Risk	22

Notes: Metal culvert buried into the woods DS- not pictured. Road Closed due to extreme erosion
