Unnamed tributary		co-1027-r-004	Sedimentation Risk Index <b>32</b>																																																																		
<u>Common:</u> 6.4mi NW of Opp <u>Drainage:</u> Yellow River <u>GPS:</u> 31.340281813, -86.340114564 <u>Land owner:</u> Dallas Henderson -DS, B&J Sasser -US		<u>County:</u> Covington <u>State:</u> Alabama <u>PLSS (T-R-S):</u> 4N-17E-3 <u>Parcel No.:</u> 8; 28 <u>Road Name:</u> Sasser Rd

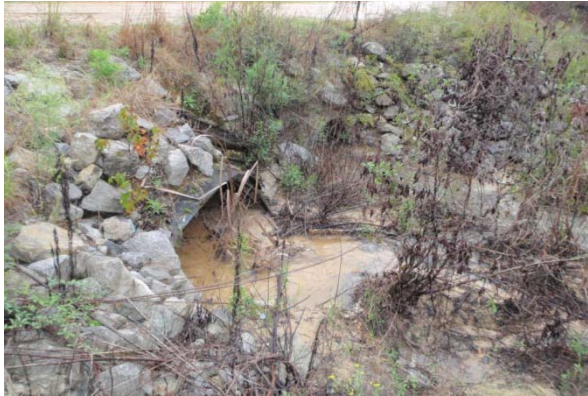
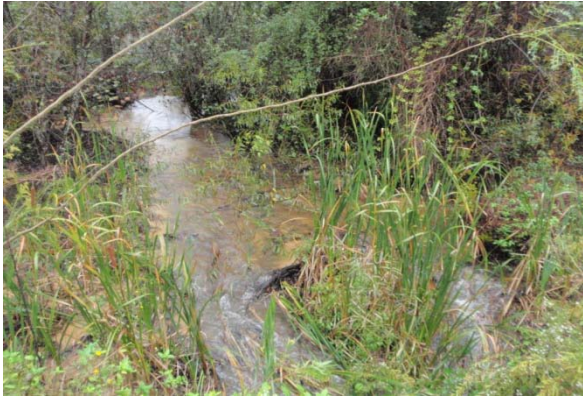
Crossing Structure: DS		US																																																																			
<table border="1"> <thead> <tr> <th>Risk Factor</th> <th>Ranking</th> <th>Score</th> </tr> </thead> <tbody> <tr><td>US Channel Morph</td><td>PONDED</td><td>1</td></tr> <tr><td>DS Channel Morph</td><td>E</td><td>5</td></tr> <tr><td>DS Bank Alteration</td><td>HIGH</td><td>1</td></tr> <tr><td>Upstream Skew Angle</td><td>&lt;5°</td><td>5</td></tr> <tr><td>Crossing fill condition</td><td>Fair/Rip Rap</td><td>3</td></tr> <tr><td>Inlet/Outlet Condition</td><td>Sed Islands/Scouring</td><td>3</td></tr> <tr><td>Road Approach Material</td><td>All Sand/Clay</td><td>3</td></tr> <tr><td>Potential Eroded Volume Mean</td><td>21-40 y<sup>3</sup></td><td>3</td></tr> <tr><td>Approach Slope Mean</td><td>&gt;4%</td><td>1</td></tr> <tr><td>Soil K Factor</td><td>&lt;0.20</td><td>5</td></tr> <tr><td>Upstream Rt Outlet</td><td>Bare soil</td><td>0</td></tr> <tr><td>Upstream Lt Outlet</td><td>Bare soil</td><td>0</td></tr> <tr><td>Upstream Rt Ditch</td><td>Bare soil</td><td>0</td></tr> <tr><td>Upstream Lt Ditch</td><td>Bare soil</td><td>0</td></tr> <tr><td>Downstream Rt Outlet</td><td>Bare soil</td><td>0</td></tr> <tr><td>Downstream Lt Outlet</td><td>Bare soil</td><td>0</td></tr> <tr><td>Downstream Rt Ditch</td><td>Bare soil</td><td>0</td></tr> <tr><td>Downstream Lt Ditch</td><td>Bare soil</td><td>0</td></tr> <tr><td>Outlet Total</td><td>Unimproved Outlet System</td><td>1</td></tr> <tr><td>Ditches Total</td><td>Unimproved Drainage System</td><td>1</td></tr> <tr><td>SRI Total</td><td>High Risk</td><td>32</td></tr> </tbody> </table>				Risk Factor	Ranking	Score	US Channel Morph	PONDED	1	DS Channel Morph	E	5	DS Bank Alteration	HIGH	1	Upstream Skew Angle	<5°	5	Crossing fill condition	Fair/Rip Rap	3	Inlet/Outlet Condition	Sed Islands/Scouring	3	Road Approach Material	All Sand/Clay	3	Potential Eroded Volume Mean	21-40 y <sup>3</sup>	3	Approach Slope Mean	>4%	1	Soil K Factor	<0.20	5	Upstream Rt Outlet	Bare soil	0	Upstream Lt Outlet	Bare soil	0	Upstream Rt Ditch	Bare soil	0	Upstream Lt Ditch	Bare soil	0	Downstream Rt Outlet	Bare soil	0	Downstream Lt Outlet	Bare soil	0	Downstream Rt Ditch	Bare soil	0	Downstream Lt Ditch	Bare soil	0	Outlet Total	Unimproved Outlet System	1	Ditches Total	Unimproved Drainage System	1	SRI Total	High Risk	32

Notes: Recently ponded by land owner (Personal communication).
