Unnamed tributary		cf-1103-r-008	Sedimentation Risk Index 40																																																																		
<u>Common:</u> 1.0mi NE of Danleys Crossroads <u>Drainage:</u> Yellow River <u>GPS:</u> 31.42209700,-86.182725070 <u>Land owner:</u> G.A. Lindsey		<u>County:</u> Coffee <u>State:</u> Alabama <u>PLSS (T-R-S):</u> 5N-19-07 <u>Parcel No.:</u> 1 <u>Road Name:</u> CR 374

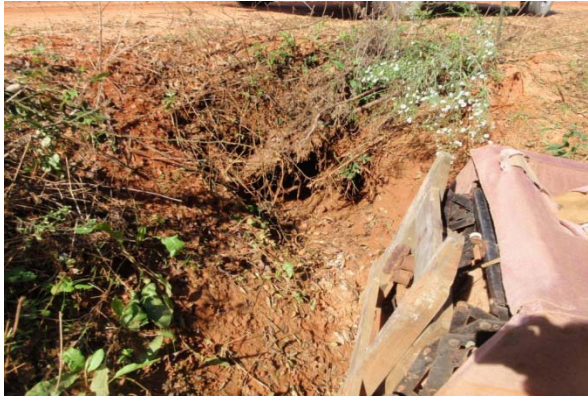
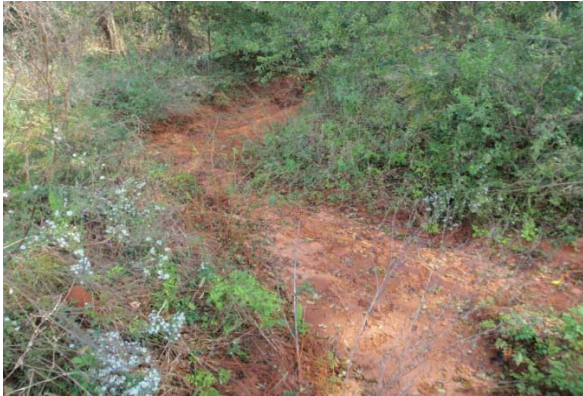
Notes: Garbage DS; culverts coming from 2 different angles US.
