Unnamed tributary		co-0904-r-013	Sedimentation Risk Index <b>34</b>																																																																		
<u>Common:</u> 8.2mi SE of Andalusia <u>Drainage:</u> Taylor Mill Creek <u>GPS:</u> 31.244398941, -86.366858575 <u>Land owner:</u> J.E. Suggs -US, Delmar & Shirley Wiggins -DS		<u>County:</u> Covington <u>State:</u> Alabama <u>PLSS (T-R-S):</u> 3N-17E-8 <u>Parcel No.:</u> 1; 7.01 <u>Road Name:</u> J.D. White Rd

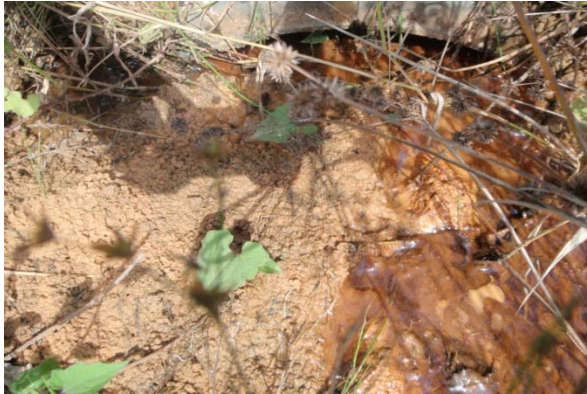
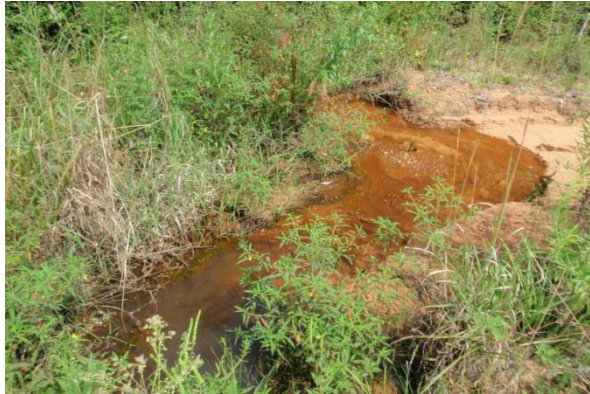
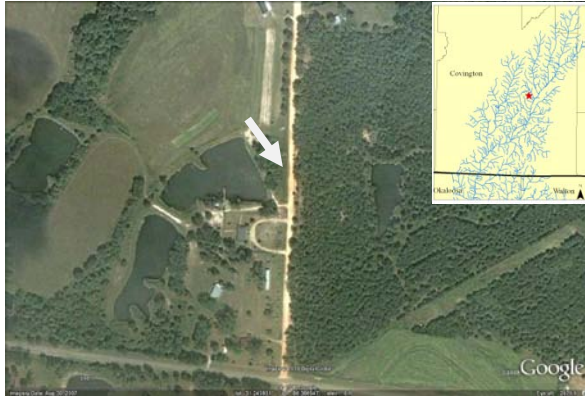
Notes: Culvert mostly buried. Poned farther US.
