Unnamed tributary		wa-0722-r-008	Sedimentation Risk Index 38																																																																		
<u>Common:</u> 5.3mi N of DeFuniak Springs <u>Drainage:</u> Gum Creek <u>GPS:</u> 30.795394, -86.138400 <u>Land owner:</u> Russell Ray- US, Dennis Ray-DS		<u>County:</u> Walton <u>State:</u> Florida <u>PLSS (T-R-S):</u> 4N-19-34-20000 <u>Parcel No.:</u> 1.10; 9 <u>Road Name:</u> Piney Grove Church Rd

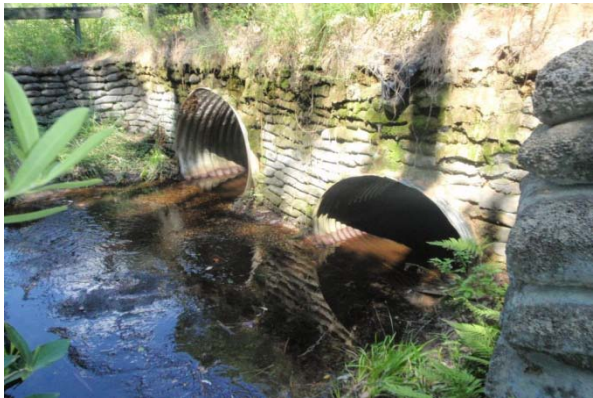
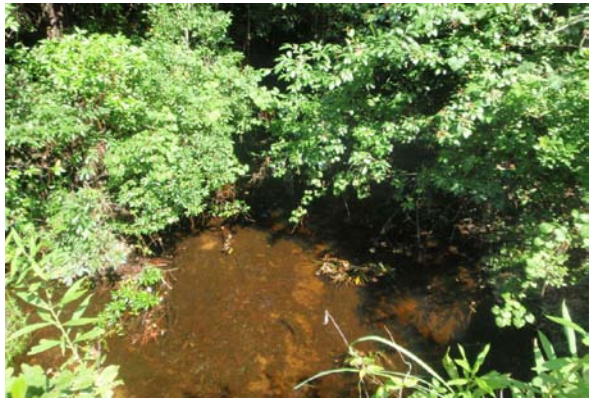
Crossing Structure: DS		US																																																																			
<table border="1"> <thead> <tr> <th>Risk Factor</th> <th>Ranking</th> <th>Score</th> </tr> </thead> <tbody> <tr><td>US Channel Morph</td><td>DA</td><td>3</td></tr> <tr><td>DS Channel Morph</td><td>DA</td><td>3</td></tr> <tr><td>DS Bank Alteration</td><td>MINOR/PARTIAL</td><td>3</td></tr> <tr><td>Upstream Skew Angle</td><td>5-30°</td><td>3</td></tr> <tr><td>Crossing fill condition</td><td>Fair/Rip Rap</td><td>3</td></tr> <tr><td>Inlet/Outlet Condition</td><td>No Impairment</td><td>5</td></tr> <tr><td>Road Approach Material</td><td>All Sand/Clay</td><td>3</td></tr> <tr><td>Potential Eroded Volume Mean</td><td>>40 y³</td><td>1</td></tr> <tr><td>Approach Slope Mean</td><td>2.1-4%</td><td>3</td></tr> <tr><td>Soil K Factor</td><td><0.20</td><td>5</td></tr> <tr><td>Upstream Rt Outlet</td><td>Vegetated</td><td>1</td></tr> <tr><td>Upstream Lt Outlet</td><td>Vegetated</td><td>1</td></tr> <tr><td>Upstream Rt Ditch</td><td>Bare soil</td><td>0</td></tr> <tr><td>Upstream Lt Ditch</td><td>Bare soil</td><td>0</td></tr> <tr><td>Downstream Rt Outlet</td><td>Vegetated</td><td>1</td></tr> <tr><td>Downstream Lt Outlet</td><td>Vegetated</td><td>1</td></tr> <tr><td>Downstream Rt Ditch</td><td>Bare soil</td><td>0</td></tr> <tr><td>Downstream Lt Ditch</td><td>Bare soil</td><td>0</td></tr> <tr><td>Outlet Total</td><td>Improved Outlet System</td><td>5</td></tr> <tr><td>Ditches Total</td><td>Unimproved Drainage System</td><td>1</td></tr> <tr><td>SRI Total</td><td>Medium Risk</td><td>38</td></tr> </tbody> </table>		Risk Factor	Ranking	Score	US Channel Morph	DA	3	DS Channel Morph	DA	3	DS Bank Alteration	MINOR/PARTIAL	3	Upstream Skew Angle	5-30°	3	Crossing fill condition	Fair/Rip Rap	3	Inlet/Outlet Condition	No Impairment	5	Road Approach Material	All Sand/Clay	3	Potential Eroded Volume Mean	>40 y ³	1	Approach Slope Mean	2.1-4%	3	Soil K Factor	<0.20	5	Upstream Rt Outlet	Vegetated	1	Upstream Lt Outlet	Vegetated	1	Upstream Rt Ditch	Bare soil	0	Upstream Lt Ditch	Bare soil	0	Downstream Rt Outlet	Vegetated	1	Downstream Lt Outlet	Vegetated	1	Downstream Rt Ditch	Bare soil	0	Downstream Lt Ditch	Bare soil	0	Outlet Total	Improved Outlet System	5	Ditches Total	Unimproved Drainage System	1	SRI Total	Medium Risk	38
