Yellow River			ok-0424-002		Severity Score 4	
<u>Common:</u> 3.8mi NW of Crestview <u>Drainage:</u> Blackwater Bay <u>GPS:</u> 30.803481, -86.612175 <u>Land owner:</u> LB: Hervis Ward/ RB: NFWFMD			<u>County:</u> Okaloosa <u>State:</u> Florida <u>PLSS(T-R-S):</u> 4N-24W-35/36 <u>Parcel No.:</u> 1/1

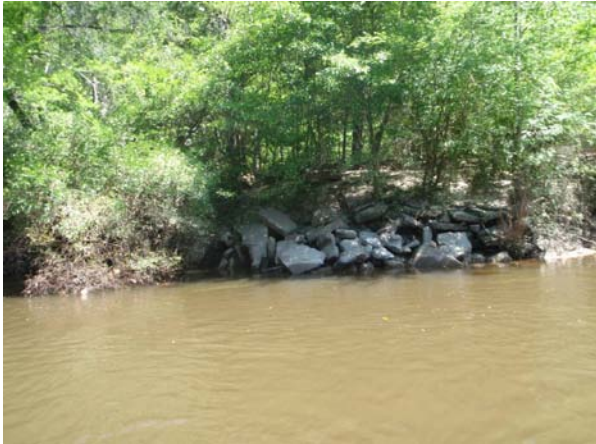
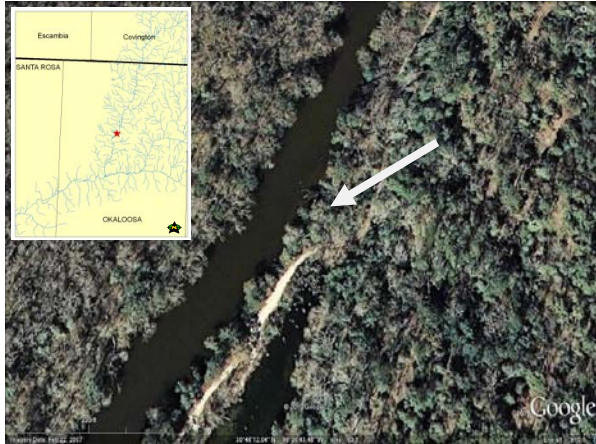
Notes: Broken concrete slabs are being used as shoring structure.
