Beaver Creek		co-0812-r-013a		Sedimentation Risk Index <b>40</b>																																																																			
<u>Common:</u> 7.3mi N of Florala <u>Drainage:</u> Clear Creek <i>GPS:</i> 31.109228, -86.323289 <u>Land owner:</u> Rayonier Forest Resources LP		<u>County:</u> Covington <u>PLSS (T-R-S):</u> 2N-17E-26 <u>Parcel No.:</u> 5 <u>Road Name:</u> Tram Rd		<u>State:</u> Alabama

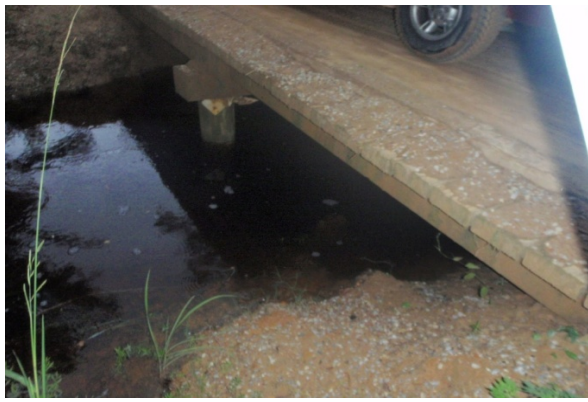
Crossing Structure: US		DS																																																																					
<table border="1"> <thead> <tr> <th>Risk Factor</th> <th>Ranking</th> <th>Score</th> </tr> </thead> <tbody> <tr><td>US Channel Morph</td><td>DA</td><td>3</td></tr> <tr><td>DS Channel Morph</td><td>DA</td><td>3</td></tr> <tr><td>DS Bank Alteration</td><td>NATURAL</td><td>5</td></tr> <tr><td>Upstream Skew Angle</td><td>&lt;5°</td><td>5</td></tr> <tr><td>Crossing fill condition</td><td>Poor/Bare soil</td><td>1</td></tr> <tr><td>Inlet/Outlet Condition</td><td>No Impairment</td><td>5</td></tr> <tr><td>Road Approach Material</td><td>All Sand/Clay</td><td>3</td></tr> <tr><td>Potential Eroded Volume Mean</td><td>&gt;40 y<sup>3</sup></td><td>1</td></tr> <tr><td>Approach Slope Mean</td><td>&lt;2%</td><td>5</td></tr> <tr><td>Soil K Factor</td><td>&lt;0.20</td><td>5</td></tr> <tr><td>Upstream Rt Outlet</td><td>Vegetated</td><td>1</td></tr> <tr><td>Upstream Lt Outlet</td><td>Bare soil</td><td>0</td></tr> <tr><td>Upstream Rt Ditch</td><td>Bare soil</td><td>0</td></tr> <tr><td>Upstream Lt Ditch</td><td>Bare soil</td><td>0</td></tr> <tr><td>Downstream Rt Outlet</td><td>Bare soil</td><td>0</td></tr> <tr><td>Downstream Lt Outlet</td><td>Bare soil</td><td>0</td></tr> <tr><td>Downstream Rt Ditch</td><td>Bare soil</td><td>0</td></tr> <tr><td>Downstream Lt Ditch</td><td>Bare soil</td><td>0</td></tr> <tr><td>Outlet Total</td><td>Partially Improved Outlet System</td><td>3</td></tr> <tr><td>Ditches Total</td><td>Unimproved Drainage System</td><td>1</td></tr> <tr><td><b>SRI Total</b></td><td><b>Medium Risk</b></td><td><b>40</b></td></tr> </tbody> </table>		Risk Factor	Ranking	Score	US Channel Morph	DA	3	DS Channel Morph	DA	3	DS Bank Alteration	NATURAL	5	Upstream Skew Angle	<5°	5	Crossing fill condition	Poor/Bare soil	1	Inlet/Outlet Condition	No Impairment	5	Road Approach Material	All Sand/Clay	3	Potential Eroded Volume Mean	>40 y <sup>3</sup>	1	Approach Slope Mean	<2%	5	Soil K Factor	<0.20	5	Upstream Rt Outlet	Vegetated	1	Upstream Lt Outlet	Bare soil	0	Upstream Rt Ditch	Bare soil	0	Upstream Lt Ditch	Bare soil	0	Downstream Rt Outlet	Bare soil	0	Downstream Lt Outlet	Bare soil	0	Downstream Rt Ditch	Bare soil	0	Downstream Lt Ditch	Bare soil	0	Outlet Total	Partially Improved Outlet System	3	Ditches Total	Unimproved Drainage System	1	<b>SRI Total</b>	<b>Medium Risk</b>	<b>40</b>

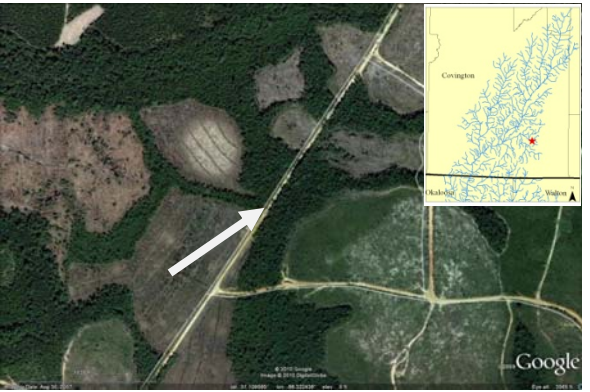
Notes: Poor outlets
