Blaze Branch		cr-1103-r-002		Sedimentation Risk Index 26																																																																			
<u>Common:</u> .56mi NW of Pine Level <u>Drainage:</u> Lightwood Knot <u>GPS:</u> 31.477386178,-86.195855819 <u>Land owner:</u> Mildred Bozema		<u>County:</u> Crenshaw <u>PLSS (T-R-S):</u> 6N-18E-24 <u>Parcel No.:</u> 3 <u>Road Name:</u> Community Rd		<u>State:</u> Alabama

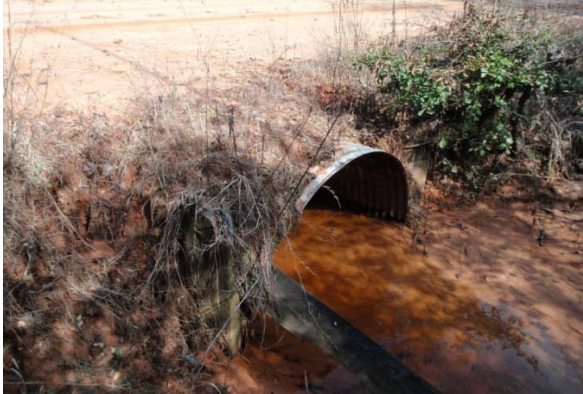
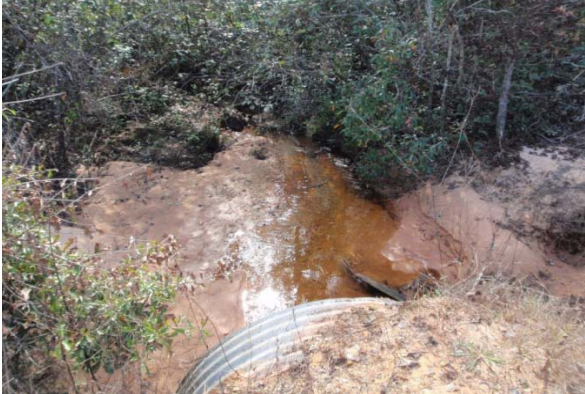
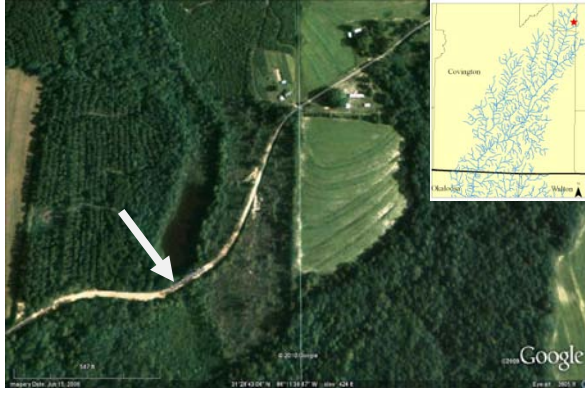
Notes: Impounded upstream, high DS bank alteration. Bare ditches and outlets also influencing score.
