Shoal River			ok-0615-011		Severity Score 3.5
<u>Common:</u> 5mi NE of Crestview <u>Drainage:</u> Yellow River <u>GPS:</u> 30.78738993, -86.490213592 <u>Land owner:</u> RB: Seagull Inc/ LB: Haiseal Timber Co			<u>County:</u> Okaloosa <u>State:</u> Florida <u>PLSS(T-R-S):</u> 3N-22W-6 <u>Parcel No.:</u> 6.001/6.001 A

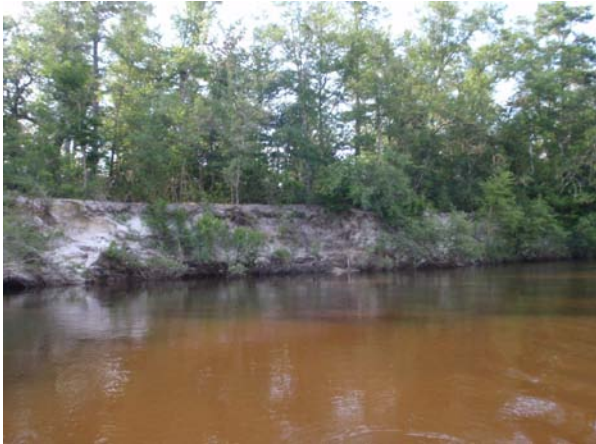
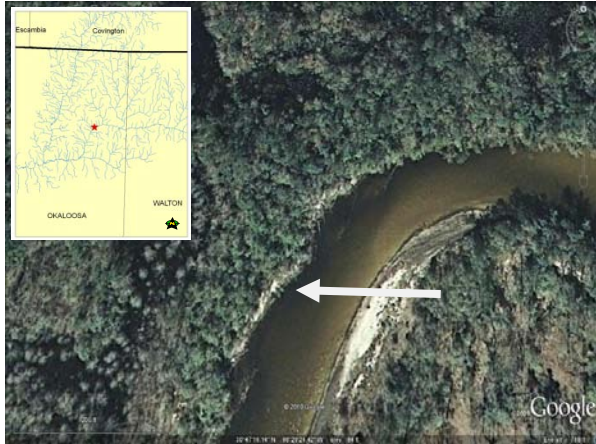
Notes: Lt Bank evidence of clear cutting. Rt bank aerals show a well defined historic meander pattern.
