Yellow River		co-0819-002	Severity Score 6																																																																				
<u>Common:</u> 8.8mi SW of Opp, Co Rd 32 bridge crossing <u>Drainage:</u> Blackwater Bay <u>GPS:</u> 31.190733, -86.360961 <u>Land owner:</u> Rayonier Woodlands		<u>County:</u> Covington <u>State:</u> Alabama <u>PLSS(T-R-S):</u> 3N-17E-33 <u>Parcel No.:</u> LLC 1/572AC

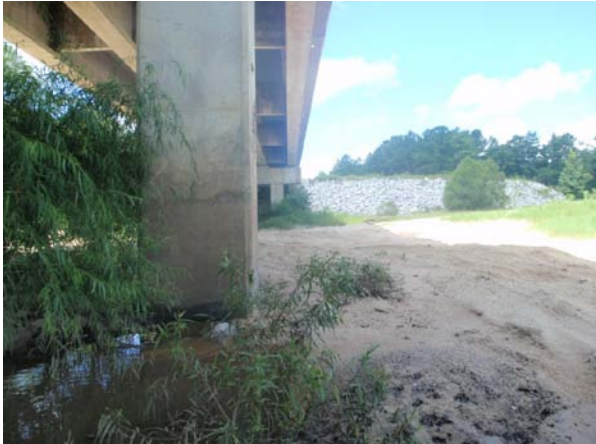
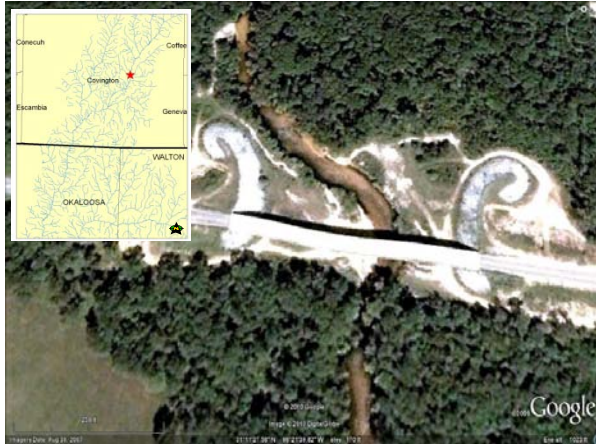
Risk Factor	Ranking	Score																																																																					
Channel Stability	Good	0.5																																																																					
Channel Alteration	Historic, Mostly Recovered	0.5																																																																					
Bank Erosion	Not Eroding	0																																																																					
BEHI	Moderate	0.5																																																																					
Local NPSP	Obvious Sources	1.5																																																																					
Shoring Structures	Present	1.5																																																																					
Pipe Discharge	Not Present	0																																																																					
Water Odors	Not Present	0																																																																					
Fish Passage Barrier	Not Present	0

Notes: Bridge crossing and campsite. Rip rap and concrete used as shoring structure.
