Shoal River		ok-0615-001		Severity Score 7.5	
<u>Common:</u> 9.1mi NW of Crestview, CR 393 Bridge Crossing <u>Drainage:</u> Shoal River <u>GPS:</u> 30.79108517, -86.42064962 <u>Land owner:</u> Donald Cunard		<u>County:</u> Okaloosa <u>PLSS(T-R-S):</u> 3N-22W-2 <u>Parcel No.:</u> 6		<u>State:</u> Florida

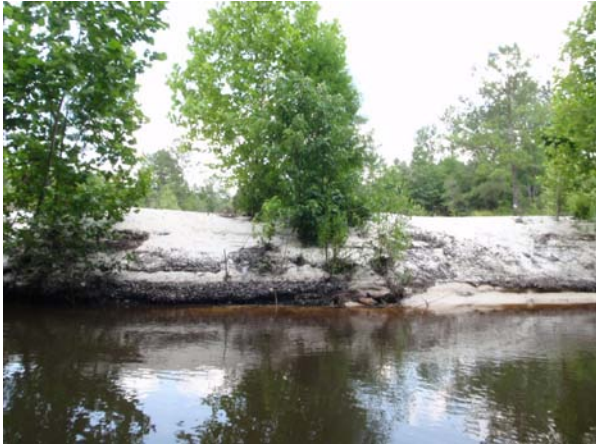
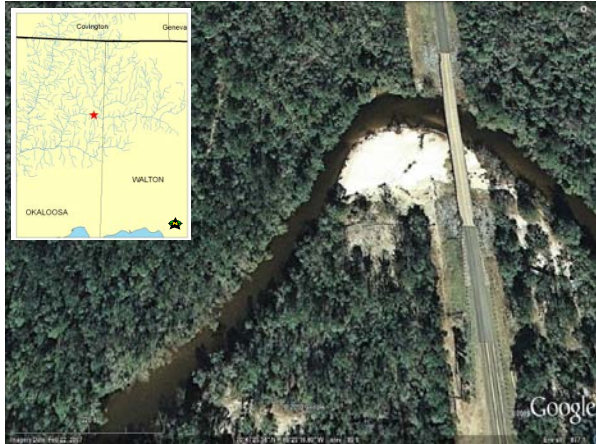
Notes: Rip rap used as shoring structure underneath CR 393 bridge. Power line crossing, bridge, and anthropomorphic evidence at this site. House boat being stored/lived in under bridge.
