Unnamed tributary		co-1027-r-007	Sedimentation Risk Index 34																																																																		
<u>Common:</u> 5.5mi NW of Opp <u>Drainage:</u> Mulberry Creek GPS: 31.344206188, -86.315045276 <u>Land owner:</u> Mary Bobo -US, Jack & Mary Odom -DS		<u>County:</u> Covington <u>PLSS (T-R-S):</u> 4N-17E-2 <u>Parcel No.:</u> 1.02; 16 <u>Road Name:</u> Oscar Pugh Rd

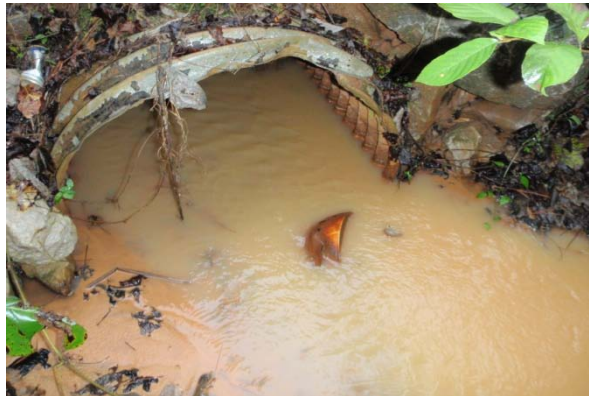
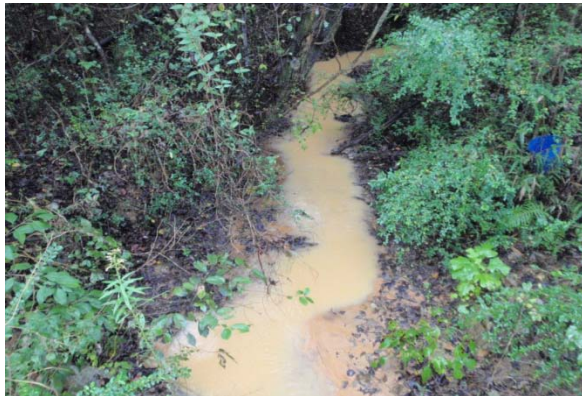
Crossing Structure: DS		DS																																																																			
<table border="1"> <thead> <tr> <th>Risk Factor</th> <th>Ranking</th> <th>Score</th> </tr> </thead> <tbody> <tr><td>US Channel Morph</td><td>PONDED</td><td>1</td></tr> <tr><td>DS Channel Morph</td><td>C</td><td>5</td></tr> <tr><td>DS Bank Alteration</td><td>HIGH</td><td>1</td></tr> <tr><td>Upstream Skew Angle</td><td>5-30°</td><td>3</td></tr> <tr><td>Crossing fill condition</td><td>Poor/Bare soil</td><td>1</td></tr> <tr><td>Inlet/Outlet Condition</td><td>No Impairment</td><td>5</td></tr> <tr><td>Road Approach Material</td><td>All Sand/Clay</td><td>3</td></tr> <tr><td>Potential Eroded Volume Mean</td><td>21-40 y³</td><td>3</td></tr> <tr><td>Approach Slope Mean</td><td>2.1-4%</td><td>3</td></tr> <tr><td>Soil K Factor</td><td><0.20</td><td>5</td></tr> <tr><td>Upstream Rt Outlet</td><td>Bare soil</td><td>0</td></tr> <tr><td>Upstream Lt Outlet</td><td>Bare soil</td><td>0</td></tr> <tr><td>Upstream Rt Ditch</td><td>Bare soil</td><td>0</td></tr> <tr><td>Upstream Lt Ditch</td><td>Bare soil</td><td>0</td></tr> <tr><td>Downstream Rt Outlet</td><td>Vegetated</td><td>1</td></tr> <tr><td>Downstream Lt Outlet</td><td>Bare soil</td><td>0</td></tr> <tr><td>Downstream Rt Ditch</td><td>Bare soil</td><td>0</td></tr> <tr><td>Downstream Lt Ditch</td><td>Bare soil</td><td>0</td></tr> <tr><td>Outlet Total</td><td>Partially Improved Outlet System</td><td>3</td></tr> <tr><td>Ditches Total</td><td>Unimproved Drainage System</td><td>1</td></tr> <tr><td>SRI Total</td><td>High Risk</td><td>34</td></tr> </tbody> </table>				Risk Factor	Ranking	Score	US Channel Morph	PONDED	1	DS Channel Morph	C	5	DS Bank Alteration	HIGH	1	Upstream Skew Angle	5-30°	3	Crossing fill condition	Poor/Bare soil	1	Inlet/Outlet Condition	No Impairment	5	Road Approach Material	All Sand/Clay	3	Potential Eroded Volume Mean	21-40 y ³	3	Approach Slope Mean	2.1-4%	3	Soil K Factor	<0.20	5	Upstream Rt Outlet	Bare soil	0	Upstream Lt Outlet	Bare soil	0	Upstream Rt Ditch	Bare soil	0	Upstream Lt Ditch	Bare soil	0	Downstream Rt Outlet	Vegetated	1	Downstream Lt Outlet	Bare soil	0	Downstream Rt Ditch	Bare soil	0	Downstream Lt Ditch	Bare soil	0	Outlet Total	Partially Improved Outlet System	3	Ditches Total	Unimproved Drainage System	1	SRI Total	High Risk	34

Notes: 1 culvert draining pond with 1.5ft drop off, 2nd culvert for road crossing.
