Five Runs Creek			co-0924-003		Severity Score 4.5	
<u>Common:</u> 9mi S of Carolina, .08mi US of Co Rd 24 bridge crossing <u>Drainage:</u> Yellow River <u>GPS:</u> 31.10748248, -86.518107393 <u>Land owner:</u> USA- Conecuh Nat. Forest			<u>County:</u> Covington <u>PLSS(T-R-S):</u> 2N-15E-26 <u>Parcel No.:</u> 1		<u>State:</u> Alabama

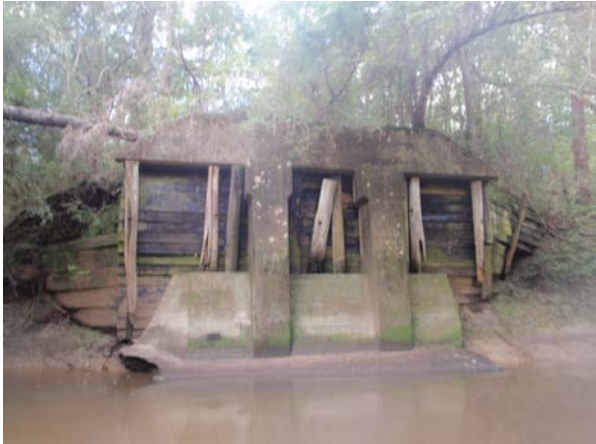
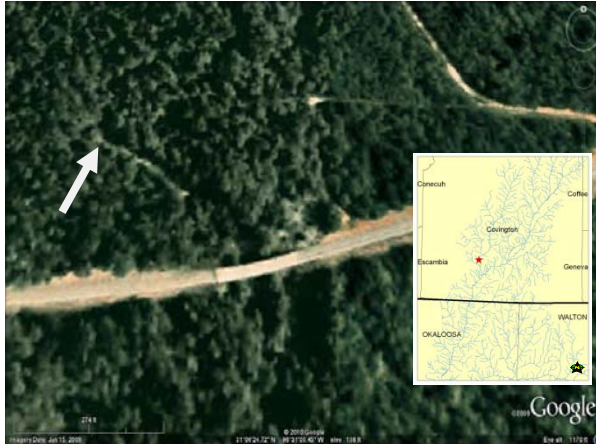
Notes: Shoring structure is concrete and wood for an old bridge crossing wall.
