Unnamed tributary		co-0904-r-001	Sedimentation Risk Index 44																																																																		
<u>Common:</u> 4.4mi SE of Andalusia <u>Drainage:</u> Five Runs Creek <i>GPS:</i> 31.248950899, -86.454617271 <u>Land owner:</u> Mary Beesley Tr. -US, Bobby Elmore -DS		<u>County:</u> Covington <u>State:</u> Alabama <u>PLSS (T-R-S):</u> 3N-16E-4/9 <u>Parcel No.:</u> 20; 3 <u>Road Name:</u> Hanegan Rd

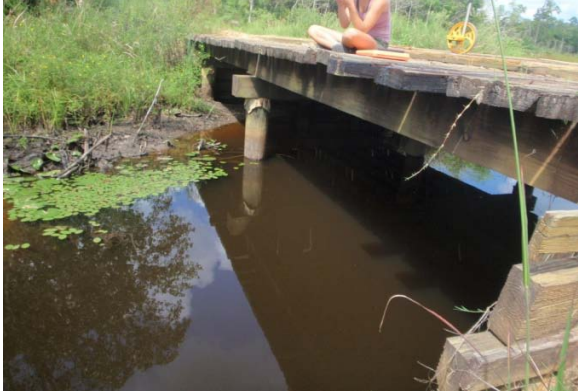
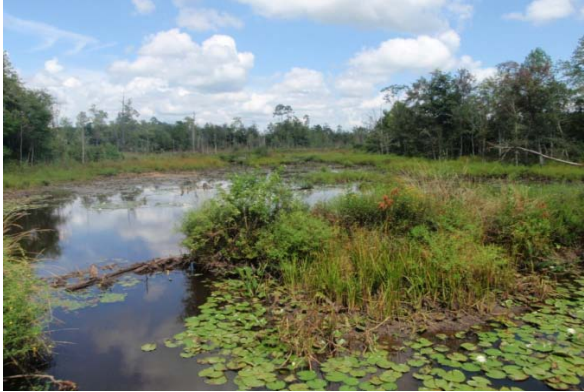
Crossing Structure: DS		US																																																																			
<table border="1"> <thead> <tr> <th>Risk Factor</th> <th>Ranking</th> <th>Score</th> </tr> </thead> <tbody> <tr><td>US Channel Morph</td><td>BEAVER DAM</td><td>3</td></tr> <tr><td>DS Channel Morph</td><td>BEAVER DAM</td><td>3</td></tr> <tr><td>DS Bank Alteration</td><td>NATURAL</td><td>5</td></tr> <tr><td>Upstream Skew Angle</td><td>5-30°</td><td>3</td></tr> <tr><td>Crossing fill condition</td><td>Good/Vegetated</td><td>5</td></tr> <tr><td>Inlet/Outlet Condition</td><td>No Impairment</td><td>5</td></tr> <tr><td>Road Approach Material</td><td>All Sand/Clay</td><td>3</td></tr> <tr><td>Potential Eroded Volume Mean</td><td><21 y³</td><td>5</td></tr> <tr><td>Approach Slope Mean</td><td>>4%</td><td>1</td></tr> <tr><td>Soil K Factor</td><td><0.20</td><td>5</td></tr> <tr><td>Upstream Rt Outlet</td><td>Bare soil</td><td>0</td></tr> <tr><td>Upstream Lt Outlet</td><td>Bare soil</td><td>0</td></tr> <tr><td>Upstream Rt Ditch</td><td>Bare soil</td><td>0</td></tr> <tr><td>Upstream Lt Ditch</td><td>Vegetated</td><td>1</td></tr> <tr><td>Downstream Rt Outlet</td><td>Vegetated</td><td>1</td></tr> <tr><td>Downstream Lt Outlet</td><td>Vegetated</td><td>1</td></tr> <tr><td>Downstream Rt Ditch</td><td>Vegetated</td><td>1</td></tr> <tr><td>Downstream Lt Ditch</td><td>Vegetated</td><td>1</td></tr> <tr><td>Outlet Total</td><td>Partially Improved Outlet System</td><td>3</td></tr> <tr><td>Ditches Total</td><td>Partially Improved Drainage System</td><td>3</td></tr> <tr><td>SRI Total</td><td>Medium Risk</td><td>44</td></tr> </tbody> </table>		Risk Factor	Ranking	Score	US Channel Morph	BEAVER DAM	3	DS Channel Morph	BEAVER DAM	3	DS Bank Alteration	NATURAL	5	Upstream Skew Angle	5-30°	3	Crossing fill condition	Good/Vegetated	5	Inlet/Outlet Condition	No Impairment	5	Road Approach Material	All Sand/Clay	3	Potential Eroded Volume Mean	<21 y ³	5	Approach Slope Mean	>4%	1	Soil K Factor	<0.20	5	Upstream Rt Outlet	Bare soil	0	Upstream Lt Outlet	Bare soil	0	Upstream Rt Ditch	Bare soil	0	Upstream Lt Ditch	Vegetated	1	Downstream Rt Outlet	Vegetated	1	Downstream Lt Outlet	Vegetated	1	Downstream Rt Ditch	Vegetated	1	Downstream Lt Ditch	Vegetated	1	Outlet Total	Partially Improved Outlet System	3	Ditches Total	Partially Improved Drainage System	3	SRI Total	Medium Risk	44

Notes: Multiple beaver dams US
