Murder Creek			ok-1105-001		Severity Score 12.5
<u>Common:</u> 9.7mi NW of Crestview, .02mi DS of Sentifitt Rd <u>Drainage:</u> Yellow River <u>GPS:</u> 30.895347188, -86.520805744 <u>Land owner:</u> Brandon Watson- DS, Richard Moulton- US			<u>County:</u> Okaloosa <u>State:</u> Florida <u>PLSS(T-R-S):</u> 5N-23W-35/26 <u>Parcel No.:</u> 1.1004; 8.00

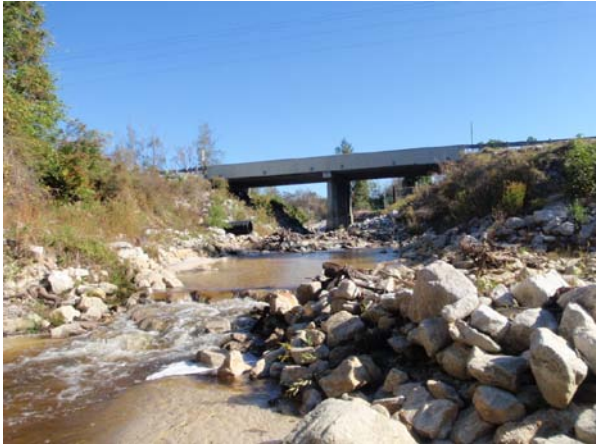
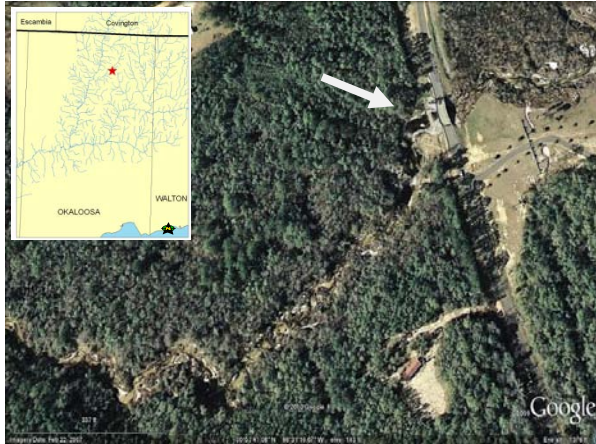
US					
Risk Factor	Ranking	Score	Feature	Within Range	Descriptive Field
Channel Stability	Fair	1	303(d)	Yes	COLIFORMS, DISSOLVED OXYGEN
Channel Alteration	In Recovery	1	Wetland Species	No	N/A
Bank Erosion	Active	1.5	Rare and Imperiled	Yes	BLACKTIP SHINER IRONCOLOR SHINER
BEHI	High	1	Land Use/ Cover	Yes	AGRICULTURAL/ WETLAND FORESTED MIX
Local NPSP	Moderate Potential	1	Candidate Mussels	No	N/A
Shoring Structures	Present	1.5	Sturgeon C.H.	No	N/A
Pipe Discharge	Present	1.5	Additional Site Features <u>Stream Channel Woody Material:</u> Infrequent <u>Impoundments:</u> Manmade (Fence and Rip Rap) <u>Substrate Composition:</u> Medium Sand <u>Bank Material:</u> Sand and Clay

Water Odors	Not Present	0			
Fish Passage Barrier	Present	1.5			
RB: Riparian Buffer	100+ft	0.75			
LB: Riparian Buffer	0-29 ft	0.75			
RB: Floodplain Access	Full	0.75			
LB: Floodplain Access	None	0.25			
River Threat Index:		12.5

Notes: Numerous amounts of rip rap in stream is causing a partial fish passage barrier, as well as a fence that the US property owner has installed upstream from the bridge. Downstream is highly entrenched and its banks are mass wasting. Banks are primarily composed of clay. View other appendices on Murder Creek for more downstream details.
