Unnamed tributary		wa-0626-r-007	Sedimentation Risk Index 44																																																																		
<u>Common:</u> 6.5mi SE of Florala <u>Drainage:</u> Turkey Creek <u>GPS:</u> 30.926158, -86.267631 <u>Land owner:</u> James & Elizabeth Hall- US, Laura Wise-Adams-DS		<u>County:</u> Walton <u>State:</u> Florida <u>PLSS:</u> 5N-20-17/20 <u>Parcel No.:</u> 5; 3.001 <u>Road Name:</u> Pittman Rd

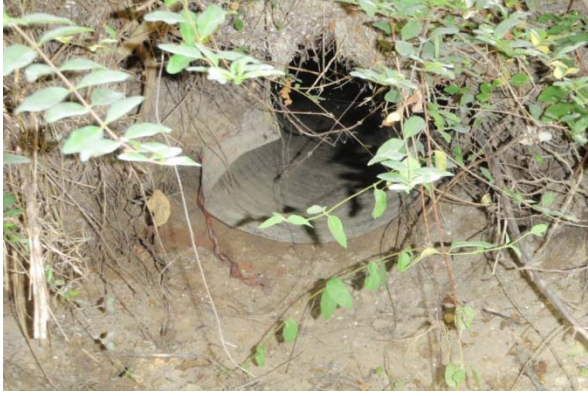
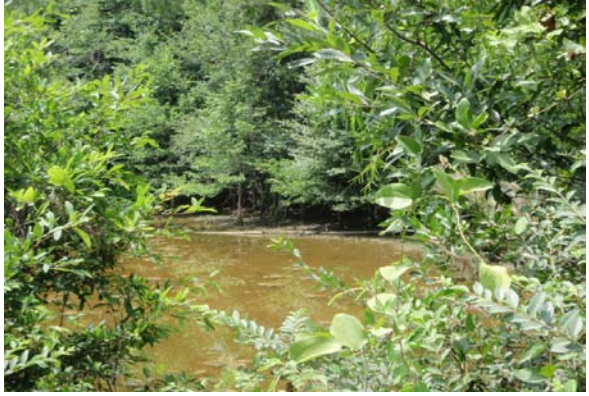
Notes: Dry at time of survey. Dead minnows in DS puddle.
