Canoe Creek		ok-0429-r-001	Sedimentation Risk Index 38																																																																		
<u>Common:</u> 7.4mi E of Harold <u>Drainage:</u> Yellow River <u>GPS:</u> 30.672943718, -86.756427066 <u>Land owner:</u> Richard & Genevieve George-US, John & Vickie Howzie-DS		<u>County:</u> Okaloosa <u>State:</u> Florida <u>PLSS(T-R-S):</u> 2N-25-16 <u>Parcel No.:</u> 3, 3.1250 <u>Road Name:</u> Log Lake Rd

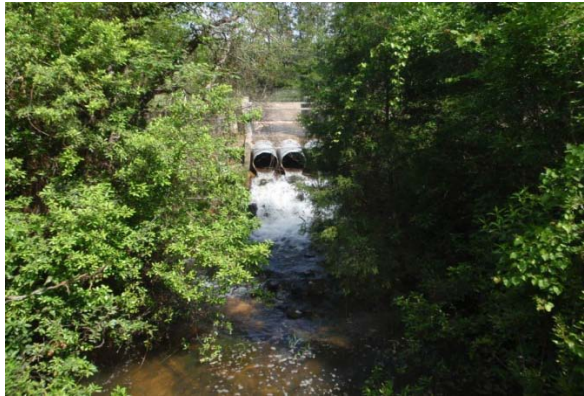
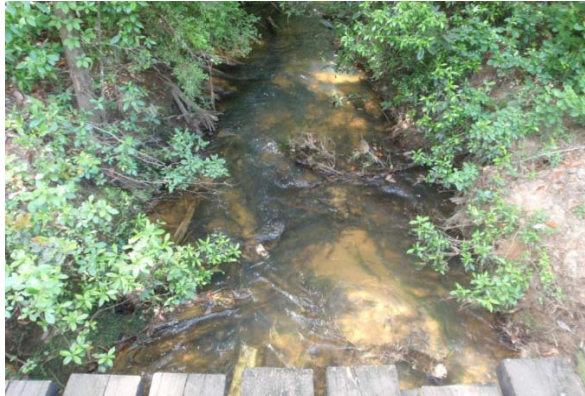
Notes: Impoundment causing fish blockage. 3 culverts US 30ft from bridge.
