Yellow River			ok-0225-005		Severity Score 8	
<u>Common:</u> 12.4mi SW of Crestview, .42 mi DS of Tarwick Creek <u>Drainage:</u> Yellow River <u>GPS:</u> 30.672143, -86.751921 <u>Land owner:</u> RB: Roland & Sara Henson/ LB: USA			<u>County:</u> Okaloosa <u>State:</u> Florida <u>PLSS(T-R-S):</u> 16-2N-25 <u>Parcel No.:</u> RB: 4.034a / LB: 2

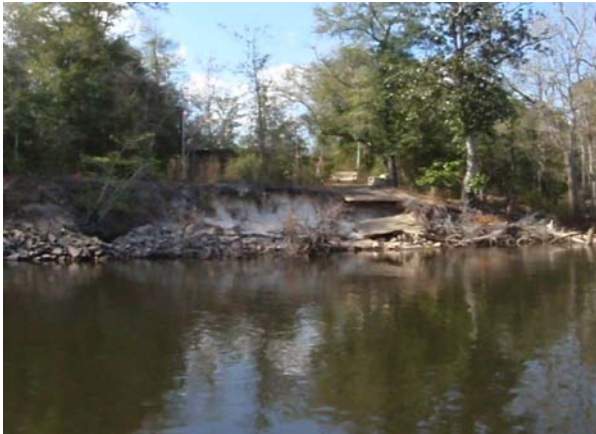
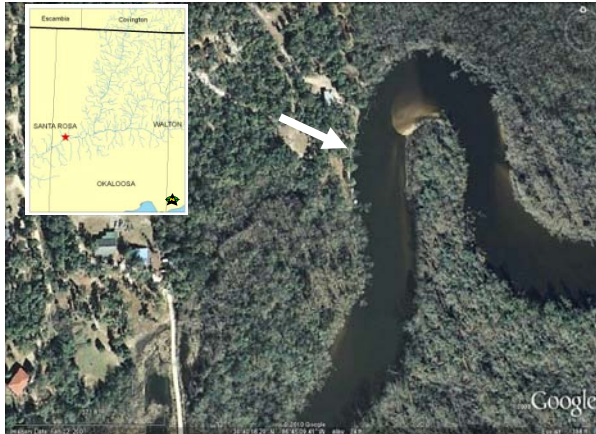
Notes: Pipe discharge coming from a small PVC pipe on right bank boat launch. Approx. 100 yards of brick and concrete shoring structure present. "Easy Street" leads to house on right bank.
