Unnamed tributary		ok-0526-r-008	Sedimentation Risk Index 42																																																																																							
<u>Common:</u> 2.9mi N of Blackman <u>Drainage:</u> Big Horse Creek <u>GPS:</u> 30.965575, -86.629023 <u>Land owner:</u> James Hart-US, Unknown-DS		<u>County:</u> Okaloosa <u>State:</u> Florida <u>PLSS(T-R-S):</u> 5N-24-03 <u>Parcel No.:</u> 4, 1.005A <u>Road Name:</u> Horsecreek Rd

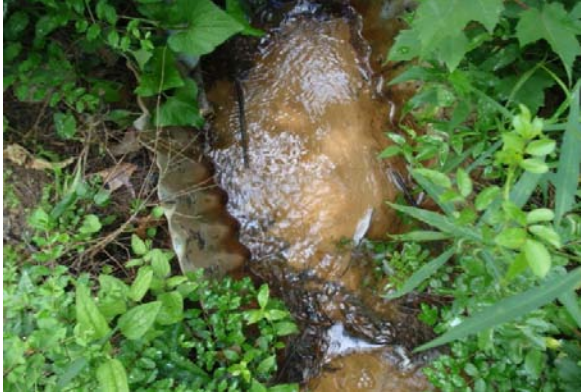
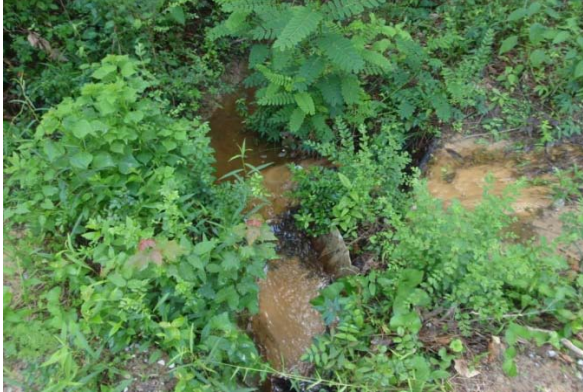
Notes: Top cut off culvert.
