Unnamed tributary		wa-0723-r-003	Sedimentation Risk Index 44																																																																		
<u>Common:</u> 7.2mi SE of Florala <u>Drainage:</u> Caney Creek <u>GPS:</u> 30.944042388, -86.230059991 <u>Land owner:</u> Elizabeth Bopp-DS, Deanna Wilson-US		<u>County:</u> Walton <u>State:</u> Florida <u>PLSS (T-R-S):</u> 5N-20-10-30000 <u>Parcel No.:</u> 7; 2.001 <u>Road Name:</u> Davis Rd

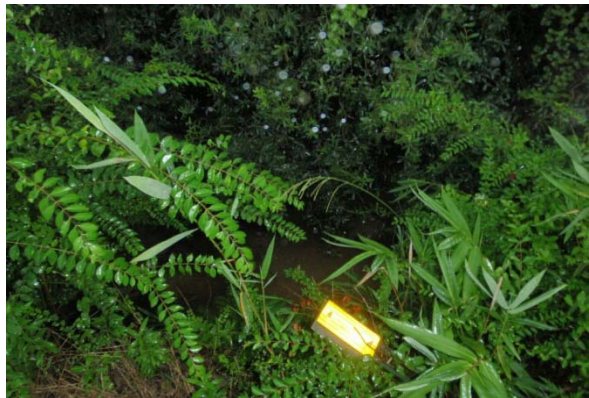
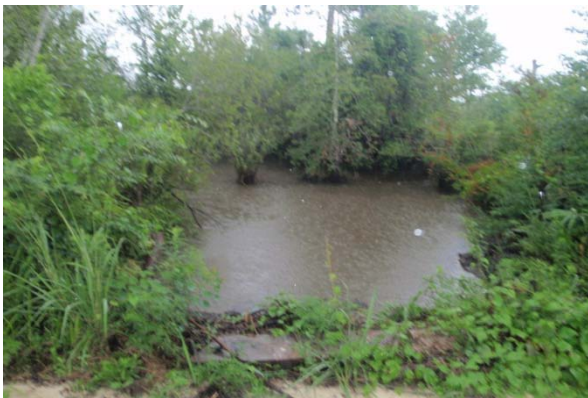
DS		US																																																																			
<table border="1"> <thead> <tr> <th>Risk Factor</th> <th>Ranking</th> <th>Score</th> </tr> </thead> <tbody> <tr><td>US Channel Morph</td><td>BEAVER DAM</td><td>3</td></tr> <tr><td>DS Channel Morph</td><td>DA</td><td>3</td></tr> <tr><td>DS Bank Alteration</td><td>MINOR/PARTIAL</td><td>3</td></tr> <tr><td>Upstream Skew Angle</td><td><5°</td><td>5</td></tr> <tr><td>Crossing fill condition</td><td>Good/Vegetated</td><td>5</td></tr> <tr><td>Inlet/Outlet Condition</td><td>Blocked</td><td>1</td></tr> <tr><td>Road Approach Material</td><td>All Aggregate</td><td>5</td></tr> <tr><td>Potential Eroded Volume Mean</td><td><21 y³</td><td>5</td></tr> <tr><td>Approach Slope Mean</td><td><2%</td><td>5</td></tr> <tr><td>Soil K Factor</td><td>0.21-0.40</td><td>3</td></tr> <tr><td>Upstream Rt Outlet</td><td>Vegetated</td><td>1</td></tr> <tr><td>Upstream Lt Outlet</td><td>Vegetated</td><td>1</td></tr> <tr><td>Upstream Rt Ditch</td><td>Bare soil</td><td>0</td></tr> <tr><td>Upstream Lt Ditch</td><td>Bare soil</td><td>0</td></tr> <tr><td>Downstream Rt Outlet</td><td>Vegetated</td><td>1</td></tr> <tr><td>Downstream Lt Outlet</td><td>Vegetated</td><td>1</td></tr> <tr><td>Downstream Rt Ditch</td><td>Bare soil</td><td>0</td></tr> <tr><td>Downstream Lt Ditch</td><td>Bare soil</td><td>0</td></tr> <tr><td>Outlet Total</td><td>Improved Outlet System</td><td>5</td></tr> <tr><td>Ditches Total</td><td>Unimproved Drainage System</td><td>1</td></tr> <tr><td>SRI Total</td><td>Medium Risk</td><td>44</td></tr> </tbody> </table>		Risk Factor	Ranking	Score	US Channel Morph	BEAVER DAM	3	DS Channel Morph	DA	3	DS Bank Alteration	MINOR/PARTIAL	3	Upstream Skew Angle	<5°	5	Crossing fill condition	Good/Vegetated	5	Inlet/Outlet Condition	Blocked	1	Road Approach Material	All Aggregate	5	Potential Eroded Volume Mean	<21 y ³	5	Approach Slope Mean	<2%	5	Soil K Factor	0.21-0.40	3	Upstream Rt Outlet	Vegetated	1	Upstream Lt Outlet	Vegetated	1	Upstream Rt Ditch	Bare soil	0	Upstream Lt Ditch	Bare soil	0	Downstream Rt Outlet	Vegetated	1	Downstream Lt Outlet	Vegetated	1	Downstream Rt Ditch	Bare soil	0	Downstream Lt Ditch	Bare soil	0	Outlet Total	Improved Outlet System	5	Ditches Total	Unimproved Drainage System	1	SRI Total	Medium Risk	44

Notes: Highly vegetated DS
