Unnamed tributary		co-0811-r-004	Sedimentation Risk Index <b>34</b>																																																																		
<u>Common:</u> 5.6mi SW of Andalusia <u>Drainage:</u> Bay Branch <u>GPS:</u> 31.227314, -86.487211 <u>Land owner:</u> Dixon Family Partnership LP		<u>County:</u> Covington <u>State:</u> Alabama <u>PLSS (T-R-S):</u> 3N-16E-18 <u>Parcel No.:</u> 1 <u>Road Name:</u> Bass Bridge Rd

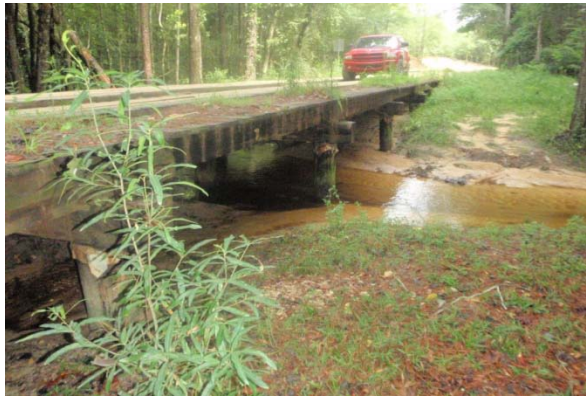
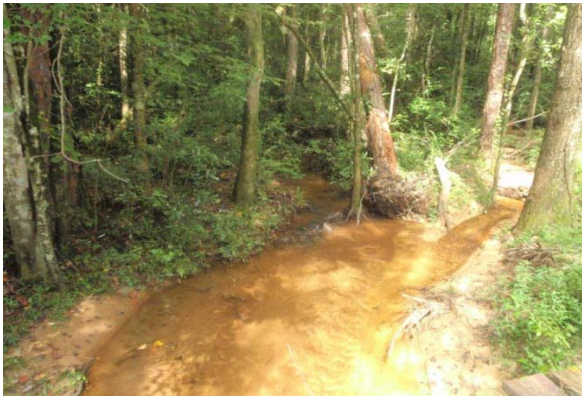
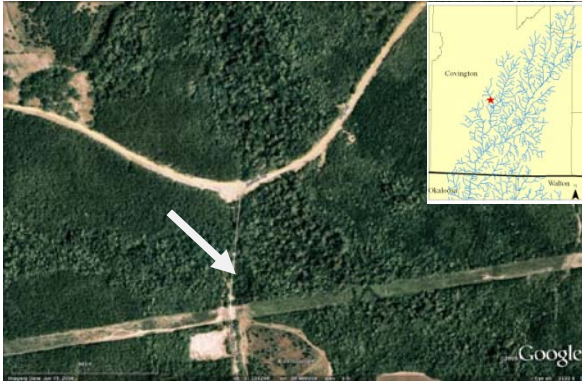
Notes: Lots of garbage in US channel and DS outlets. 1/2 up RT approach clay pit.
