Yellow River			ok-0319-007		Severity Score 2.5	
<u>Common:</u> 7.4mi SW of Crestview <u>Drainage:</u> Blackwater Bay <u>GPS:</u> 30.672025, -86.719466 <u>Land owner:</u> RB: NFWFMD / LB: USA			<u>County:</u> Okaloosa <u>PLSS:</u> 2N-25W-14 <u>Parcel No.:</u> 1 / 2		<u>State:</u> Florida

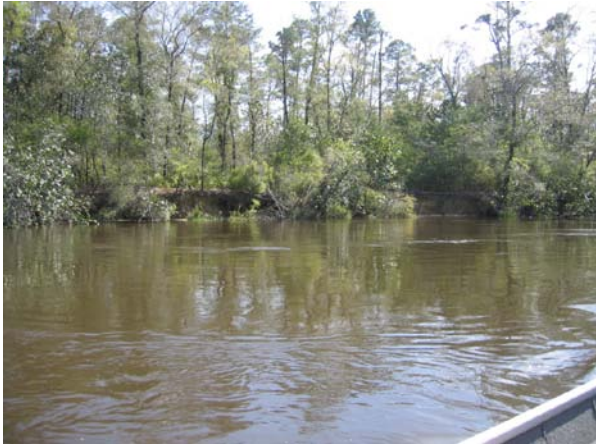
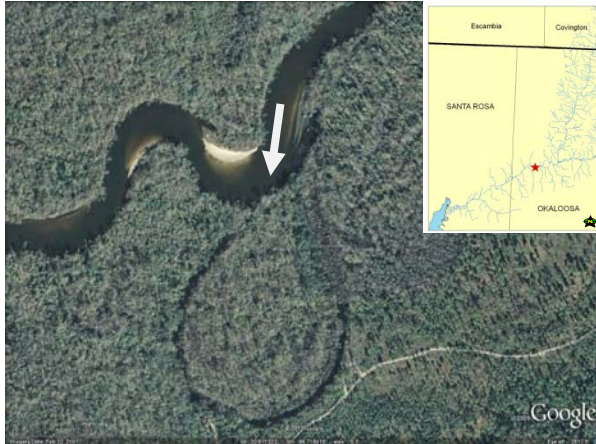
Notes: Old silviculture site? Very limited old growth, mostly the first few feet on top of the bank. The vegetation beyond the initial floodplain coverage is clearly young growth. Aerial image shows evidence of the old lateral meander channel.
